Beacon Park

Desilting and restoring a lake in Lichfield.

Salix were employed to undertake the restoration work to Beacon Pool for Lichfield Council on this Heritage lottery funded project.

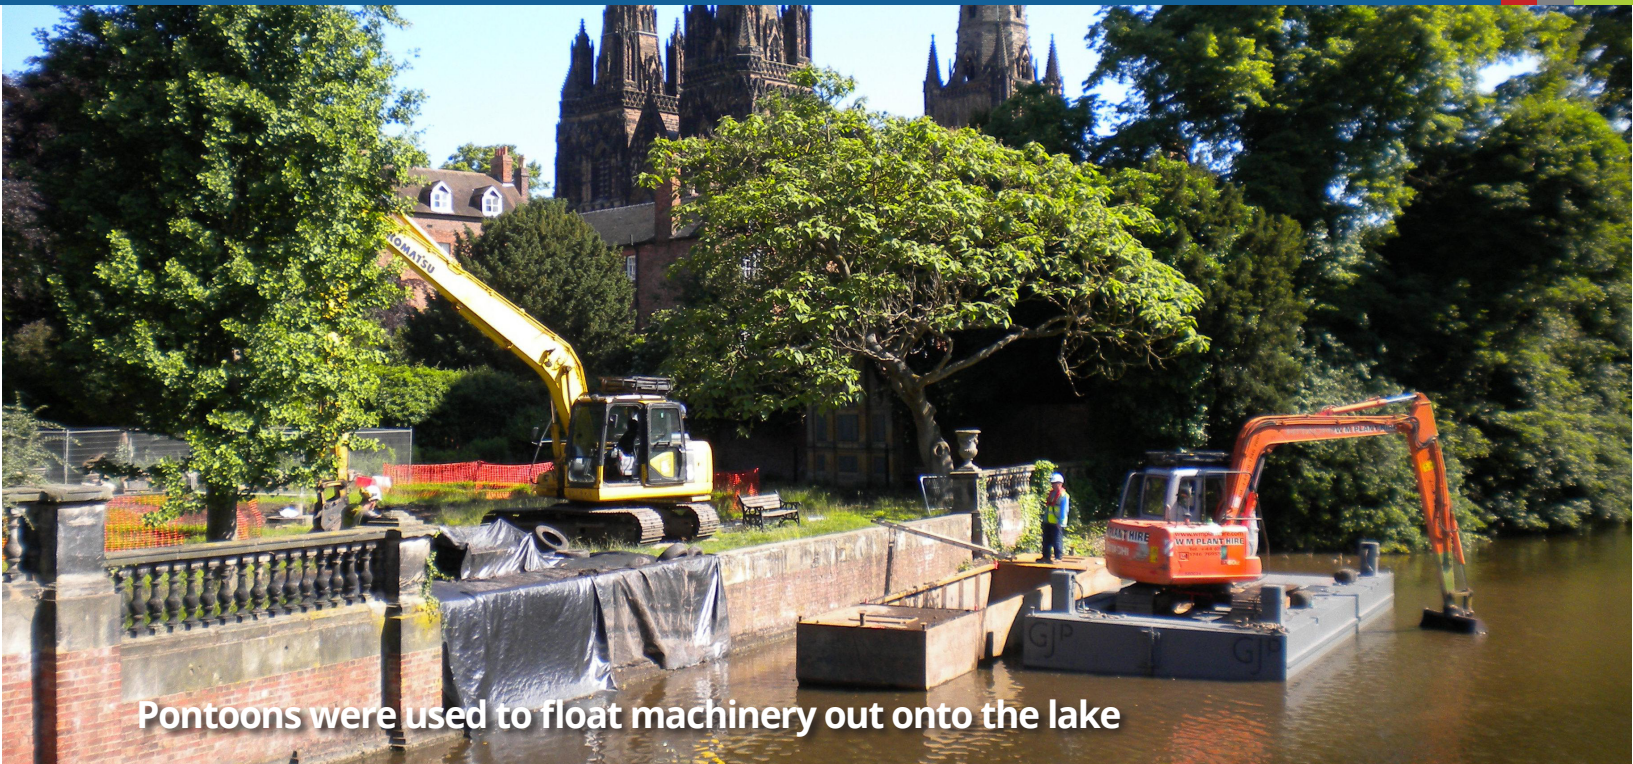
Pontoons were used to float machinery out onto the lake

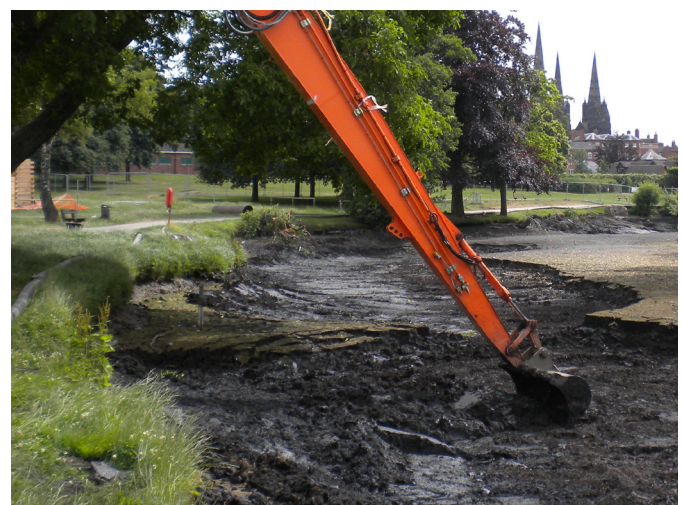
Long reach excavators were used to desilt

Silt was then removed using long reach excavators on timber tracking mats as access to the bed was not possible in water logged peat. The silts were placed in a drying area on site for use in landscaping.

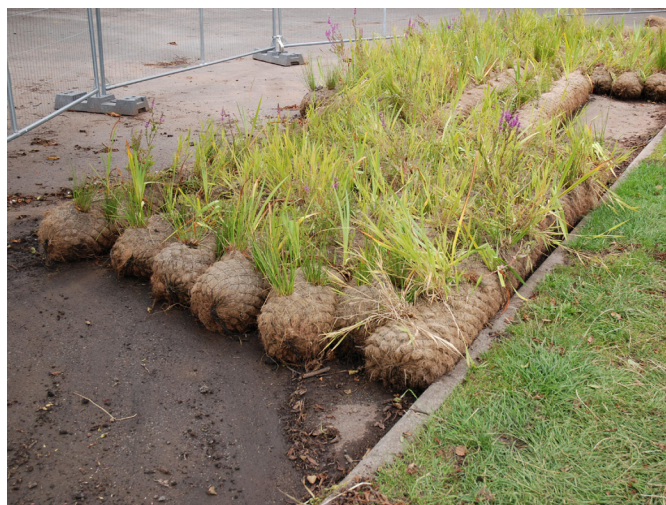
Pre-established Coir Rolls

The erosion was controlled by placing pre established coir rolls over faggot bundles. The rolls were then backfilled with silt from the lake to fill voids created by undercutting wave lap action.

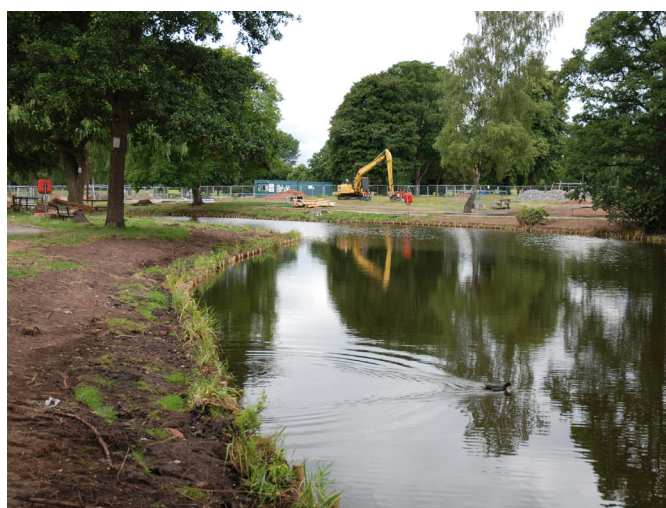
Coir Rolls in place immediately after installation

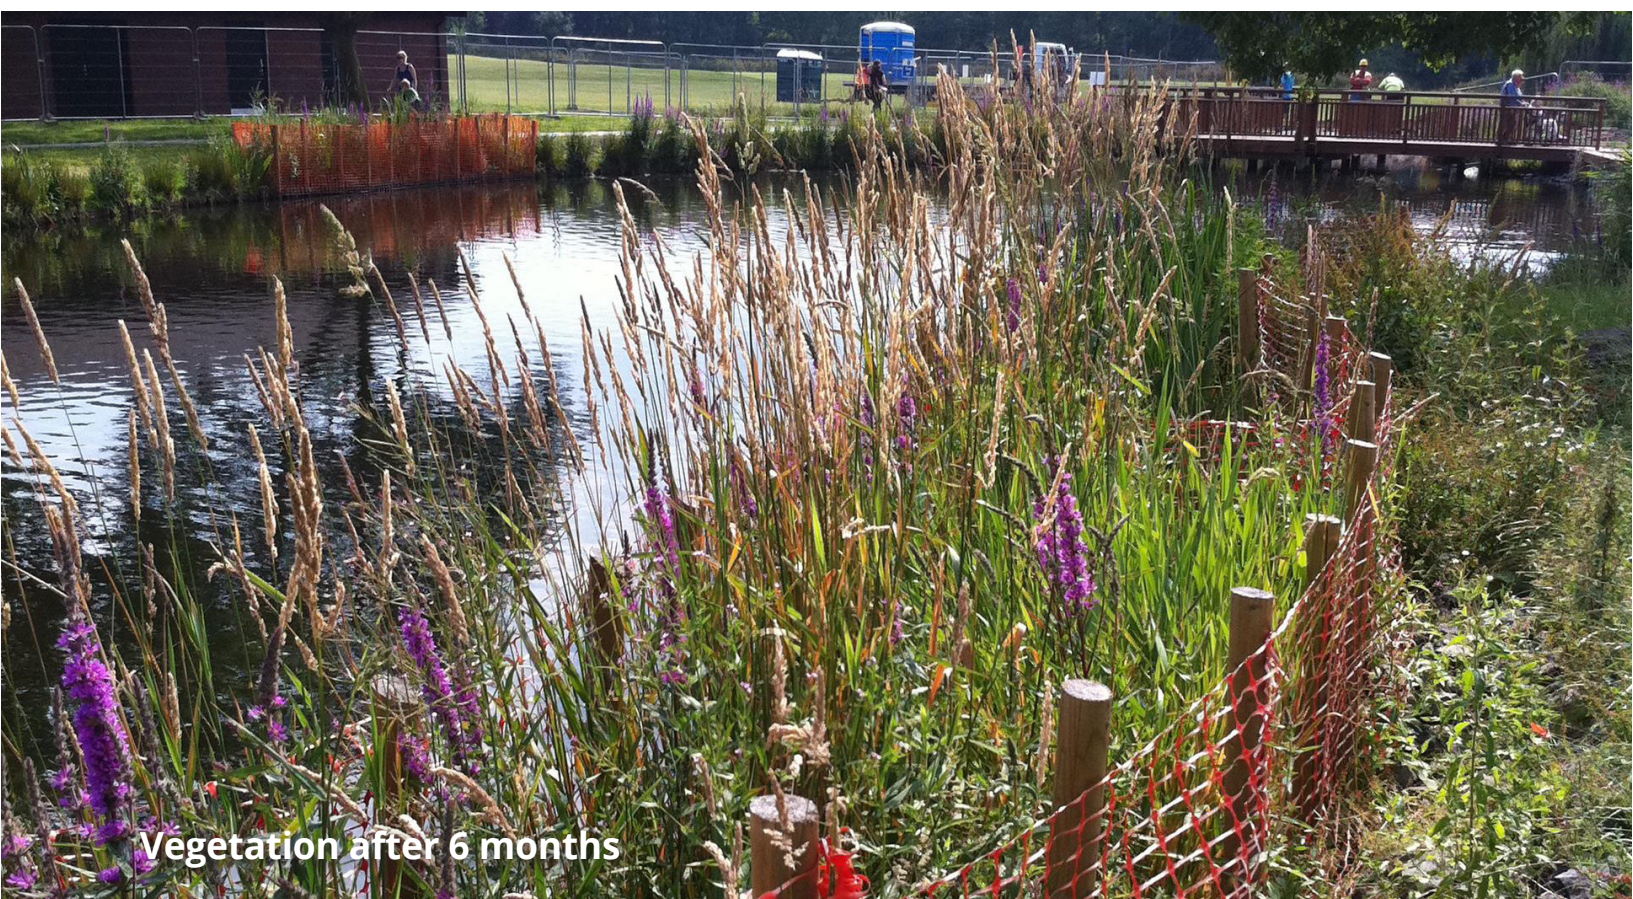
Vegetation after 6 months
