Calverton Tip Drainage Channels

PROJECT NAME :	Calverton Tip Drainage Channels
CLIENT :	Walters UK for Coal Authority
LOCATION :	Calverton, Nottingham
PROJECT CATEGORY :	SUDS and Drainage Channels

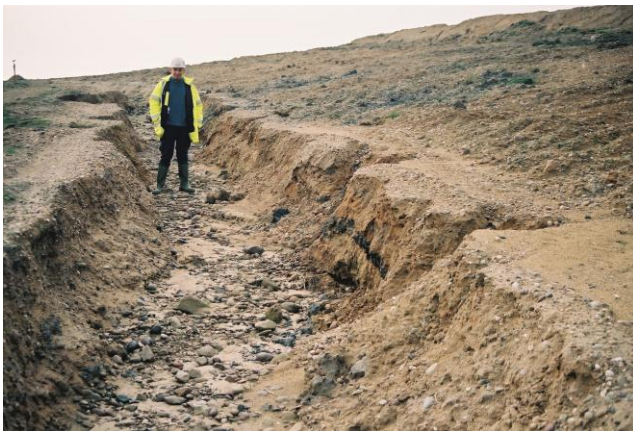
48hr flood event created severe scour

The eroded channels were re-profiled and shaped in March 2004 and seeded and protected with the C350 within a two-week period. The seed and fertilizer were protected from washout by flows in the channel from day one. An added benefit was the rate at which vegetation began to establish due to the mulching effect of the coir fibre composite layer in the 3-D net of the C350.

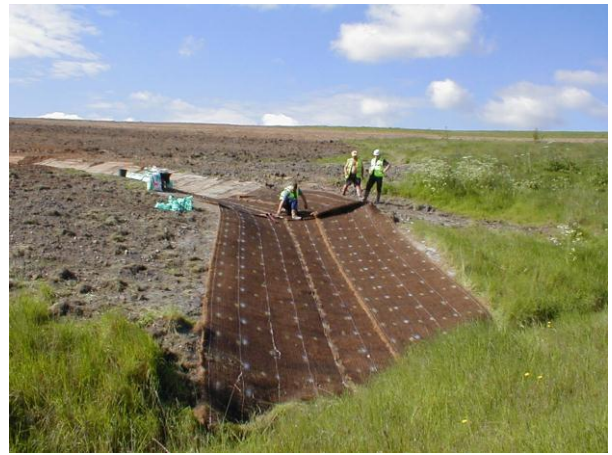
Vmax C350 manually installed

The only product that would meet both the short term erosion control of the bare recently seeded soil whilst also giving three-dimensional reinforcement to the vegetation once established was NAG's V-Max range of products. The ECMDS analysis showed that the C350 Composite Turf Reinforcement Mat (C-TRM) would provide the short term erosion control function and also reinforce the vegetation to withstand the storm flow events.

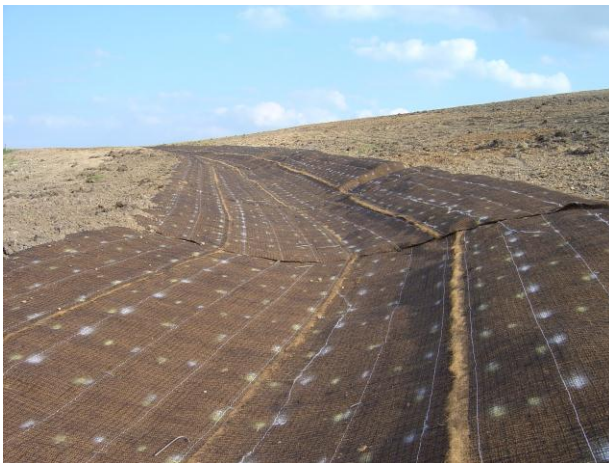
Over 1km of channel protected

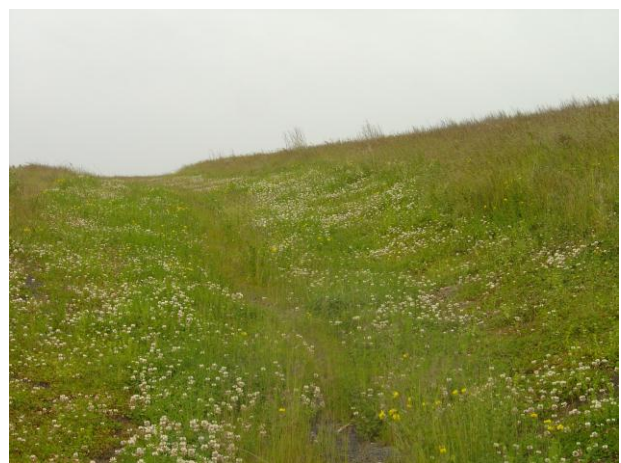
Good vegetation cover on poor soils

The channels were tested early on after completion with numerous storm events occurring in the first few months. The high level of erosion control performance provided by the C350 prevented any erosion of fines or loss of seed. Vegetation is well on its way with 60 – 80% cover in the first year and the project is deemed a success by all those involved.
