## River Darwen Riverbank Stabilisation Project

Salix worked with National Grid to stabilise a bank which had eroded close to a pipeline.

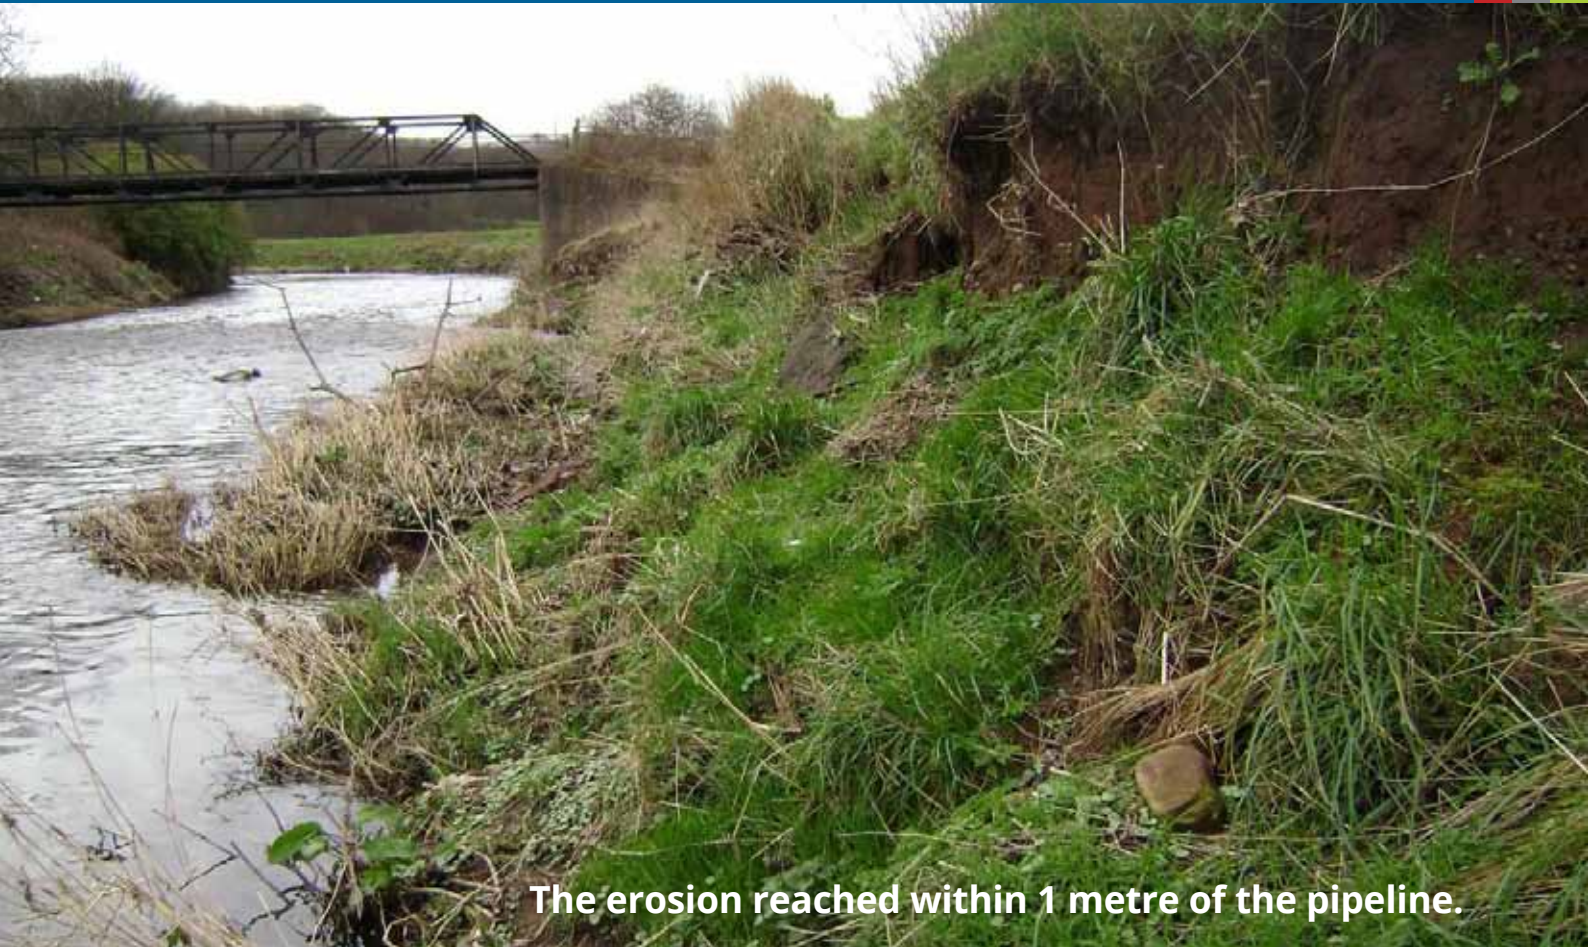
**The erosion reached within 1 metre of the pipeline.**

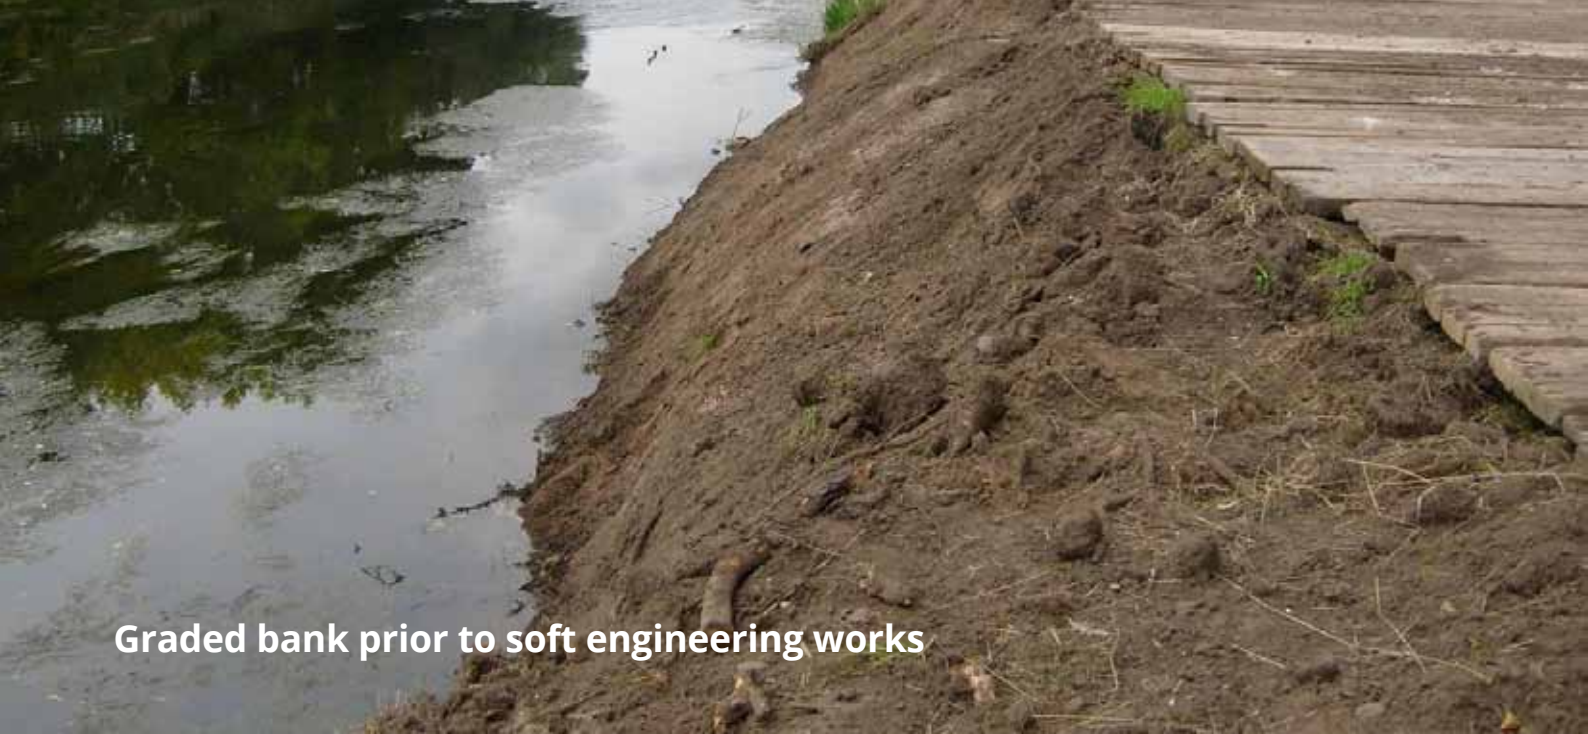
**Graded bank prior to soft engineering works**

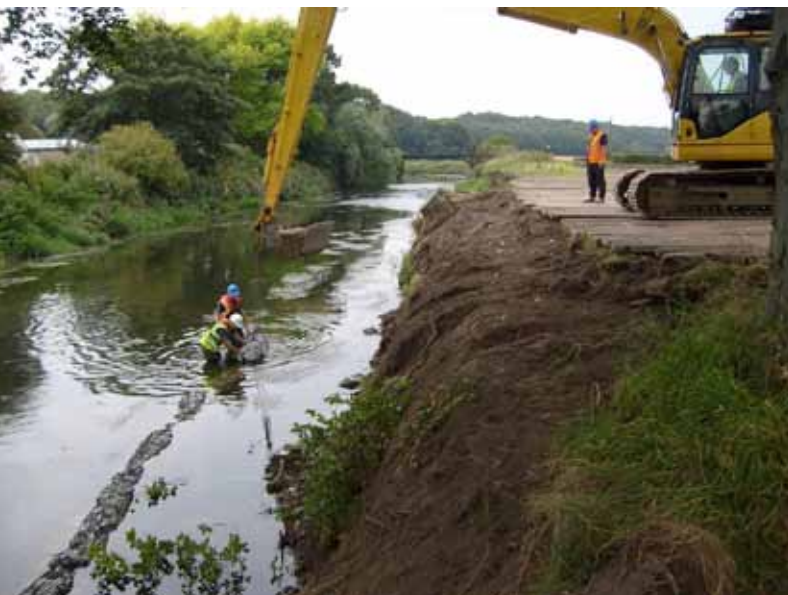
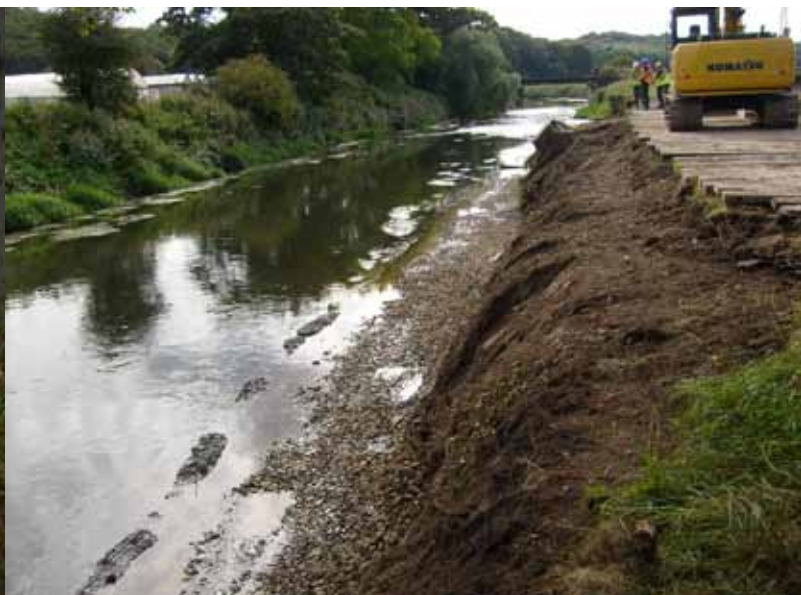
Rock Rolls are installed to create a toe revetment and also to act as a coffer dam to prevent sediment release from the bank works.

Stone is used as backfill up to average summer water level. Locally won soil is used above this level

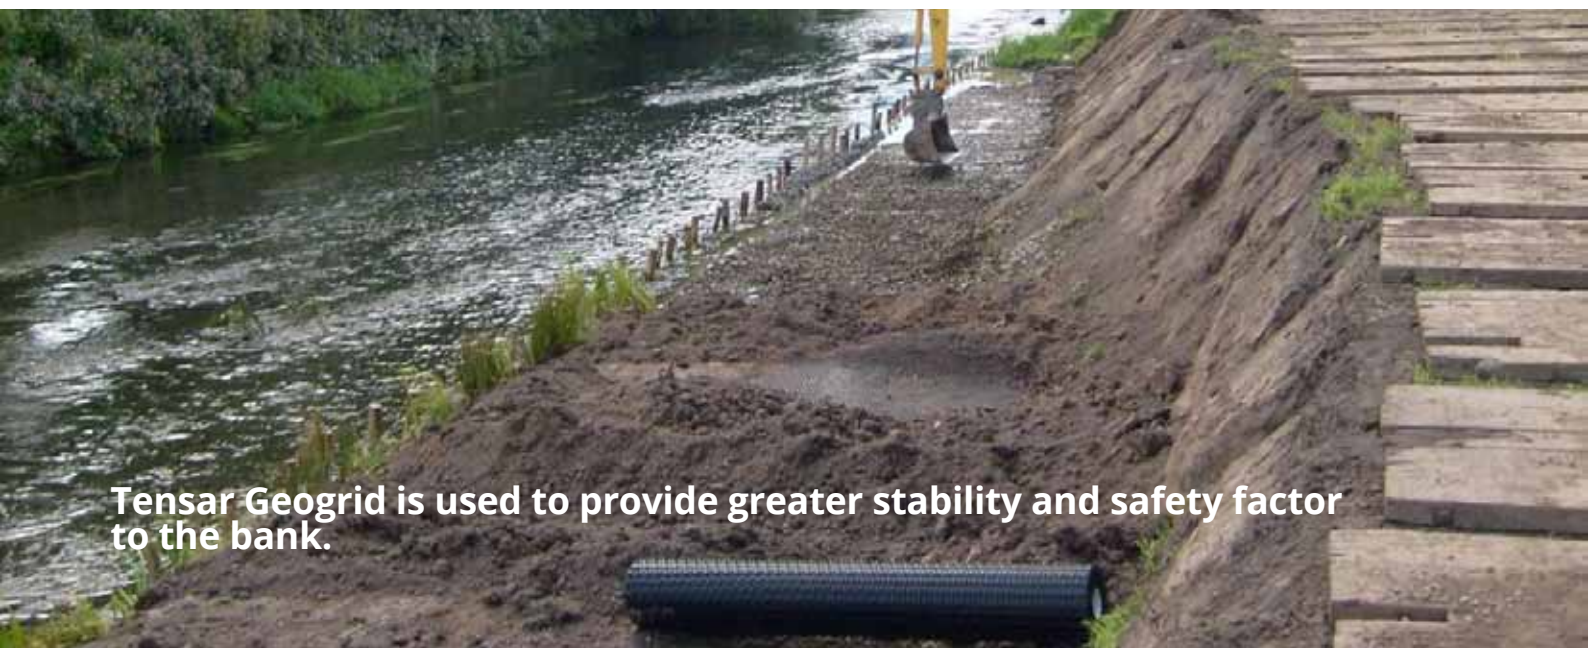
**Tensor Geogrid is used to provide greater stability and safety factor to the bank.**

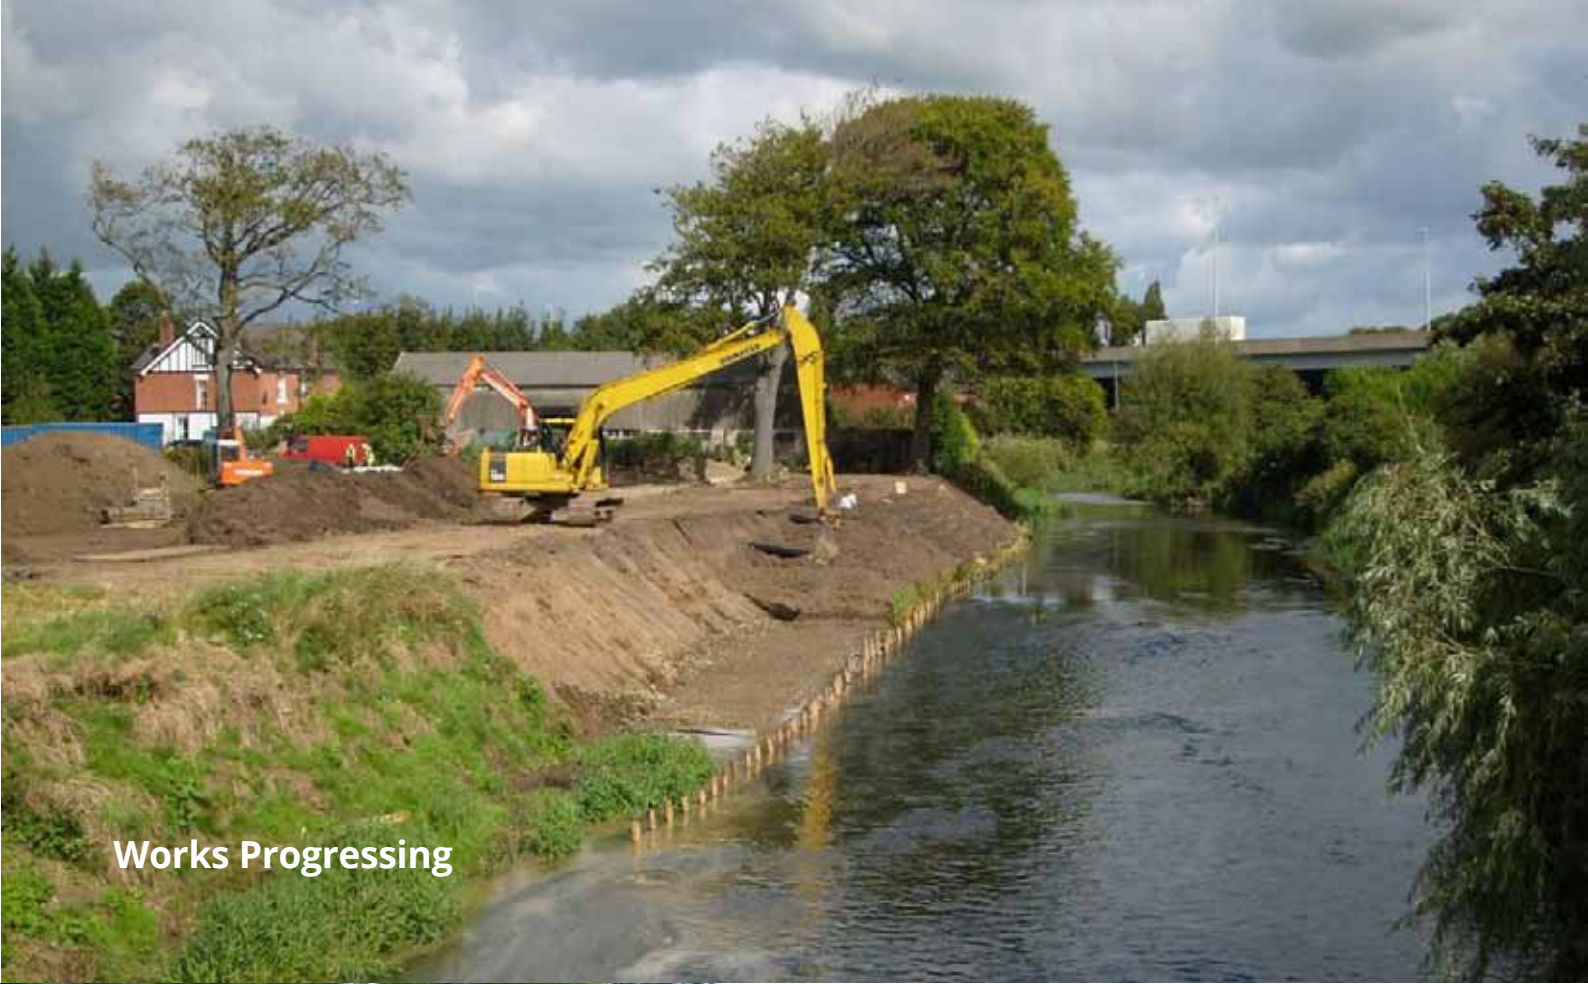
**Works Progressing**

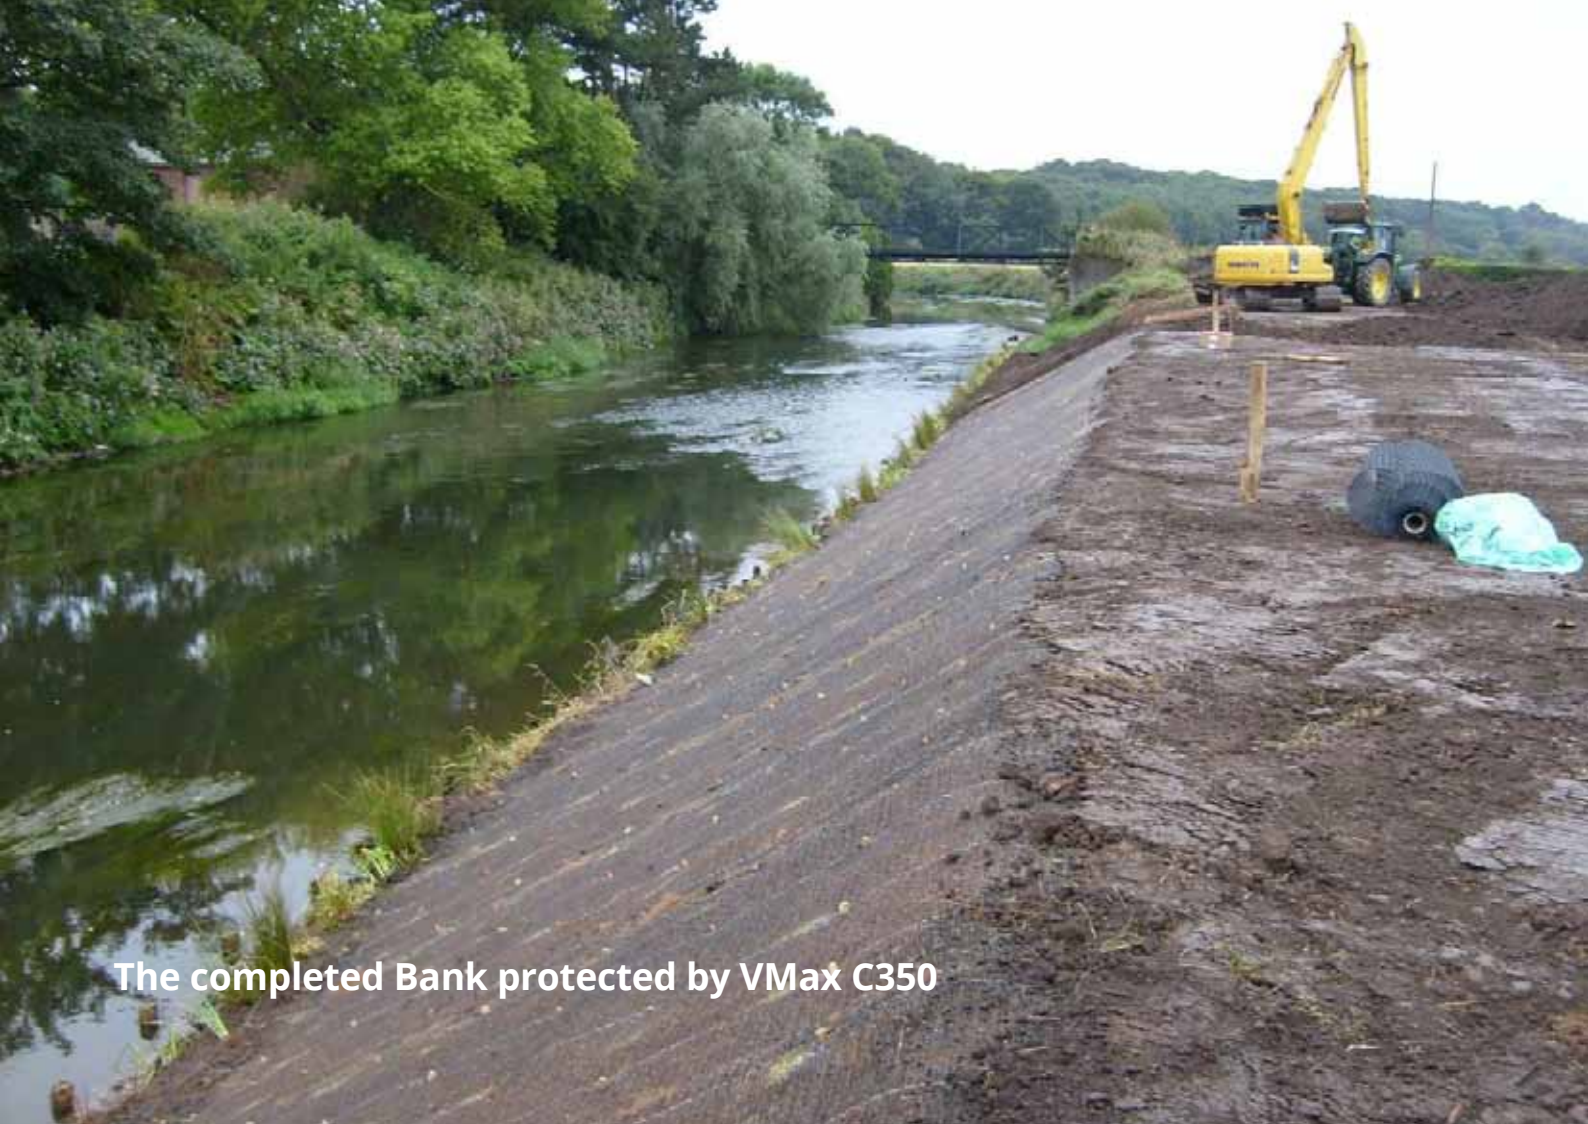
**The completed Bank protected by VMax C350**

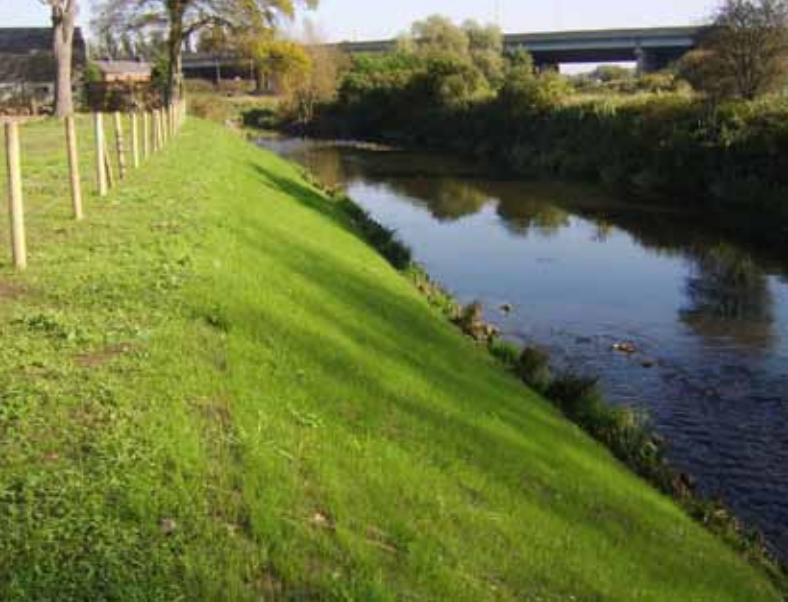
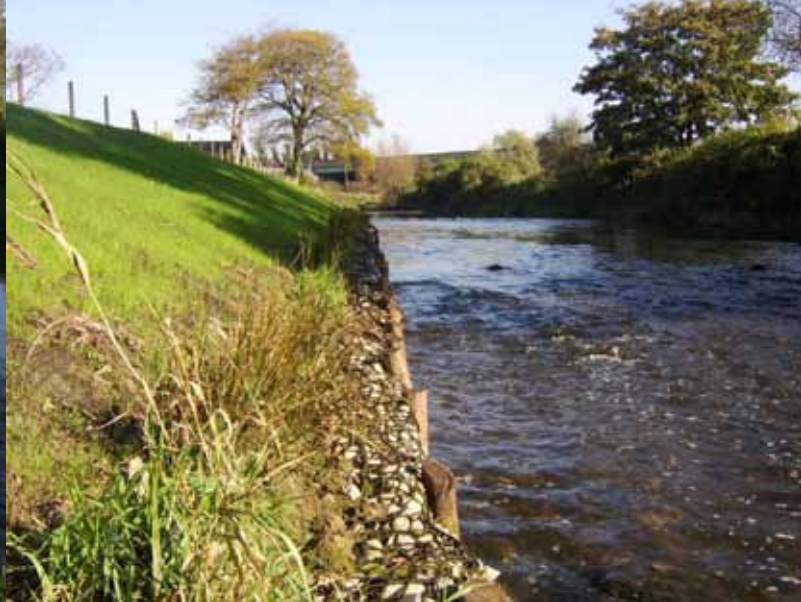
Above: Vegetation establishment 4 weeks after installation in October.

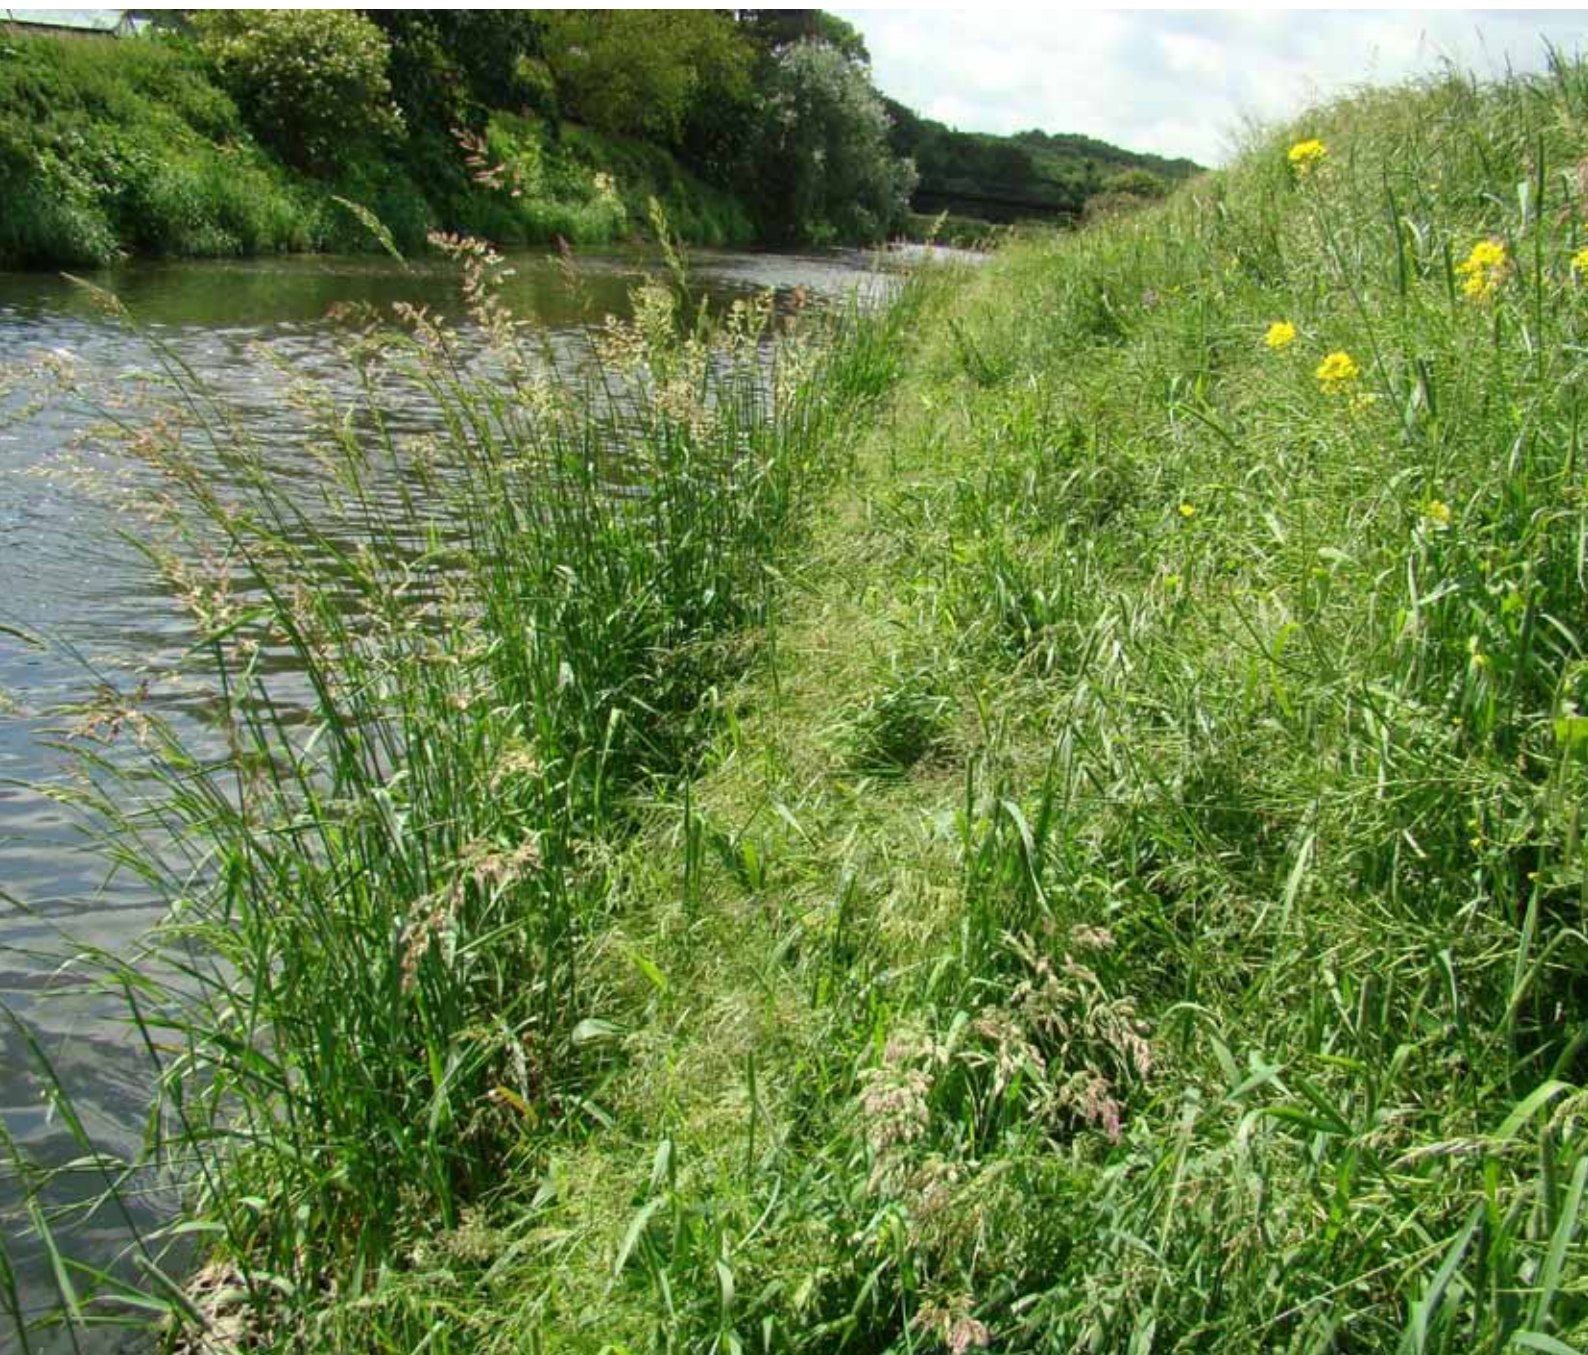
Below: Vegetation establishment in May of the following year. Note the Reed Canary Grass (*Phalaris arundinacea*) establishment in the coir rolls. This is a key stabilising grass in many gravel bed river catchments.
