### Kelham Island Goit

<b>PROJECT NAME :</b>	Kelham Island Goit
<b>CLIENT :</b>	Mansell
<b>LOCATION :</b>	Kelham Island, Sheffield
<b>PROJECT CATEGORY :</b>	Dredging

Salix were contracted by Mansell construction to dredge the contaminated Goit forming Kelham Island and working closely with ecologists ECUS to create marginal habitat.

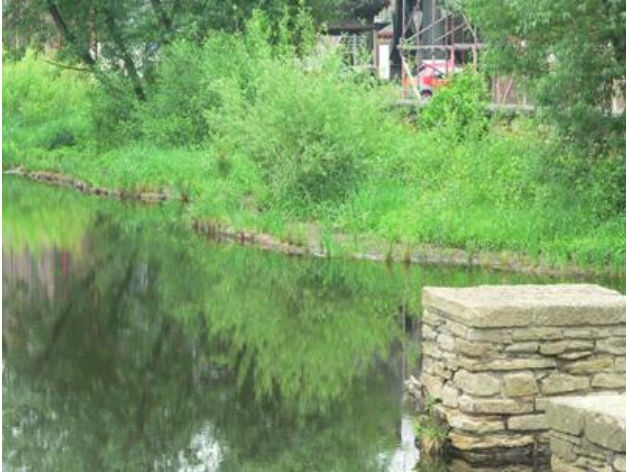
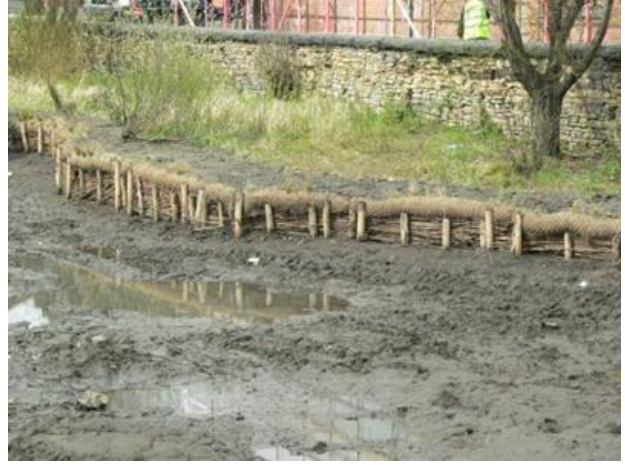
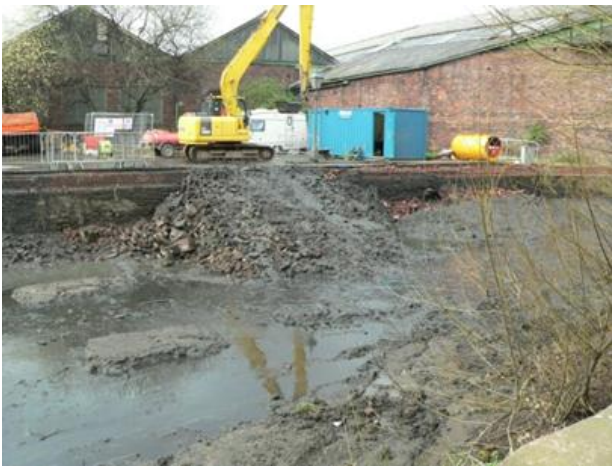
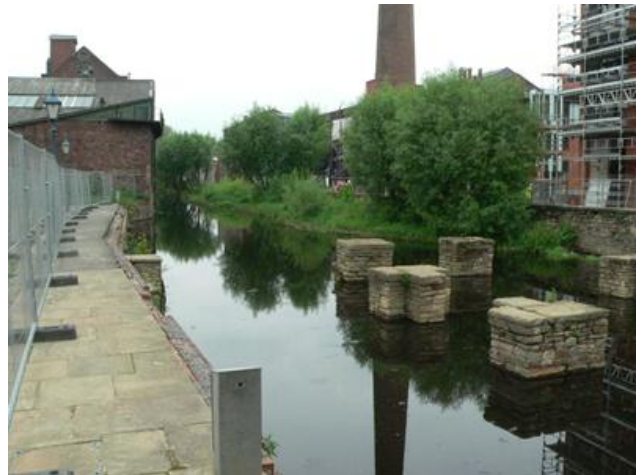
Salix desilted the goit using tracked dumpers within the goit and transferring the silt into sealed road Lorries for disposal at a specialist landfill site in Middlesbrough.

Wildlife margin was established along the museum side of the goit by using pre established coir rolls to maintain soft banking in the now through flowing goit.

Flow control was established by replacing the steel sluice gate leading from the River Don and Replacing the Double timber sluice gates at the goit outfall.
