Emergency Works on a Pipeline in a Stream

Salix were brought in as specialist contractors to help deal with an exposed pipeline, in a river near Johnstown, Carmarthen.

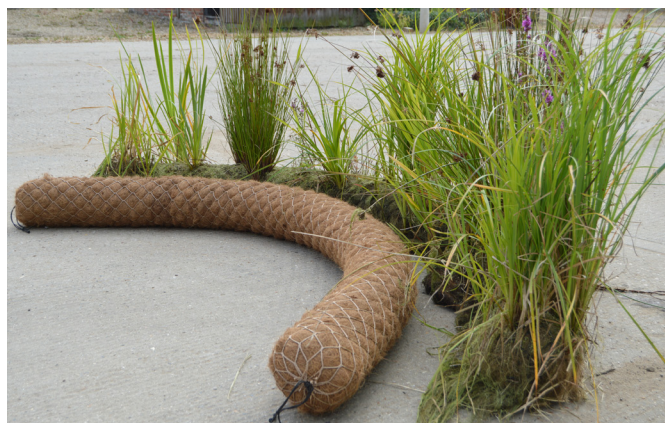
Two trees growing on the river bank had dramatically narrowed the river, impacting the flow and created a large scour pool directly over the pipeline.

Salix's Rock Rolls, erosion control coir matting and pre-planted Coir Rolls were used to ensure the riverbanks were protected from erosion.

Salix went on site and did a full geomorphological and ecological survey of the site and recommended the site was dewatered whilst the pipeline was moved to a more stable channel crossing point.

The riverbanks were protected from erosion through the installation of Rock Rolls, pre-planted Coir Rolls and coir matting.

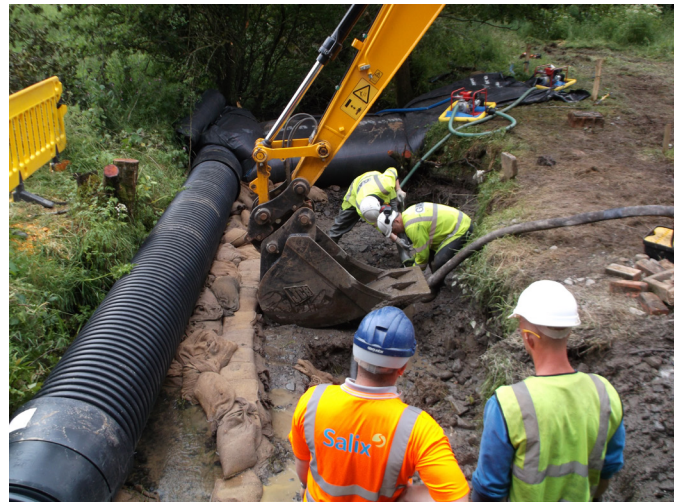
The river was safely dewatered whilst the pipe was moved

To ensure that there was as little impact on the local ecology as possible the river was redirected through a pipe, which allowed the client to dig up the river bed and move the asset.

The bed was reinstated with an additional cover of 250mm of stone over the pipeline.

The bed was raised to achieve a minimum cover of 750mm and was achieved by a small fixed riffle feature (only 3 metres long).

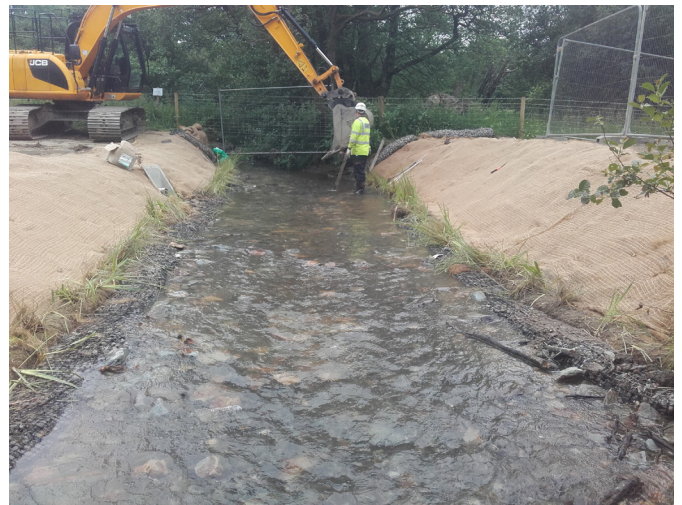
Erosion control coir matting, Rock Rolls and preplanted Coir Rolls in place and the river reinstated

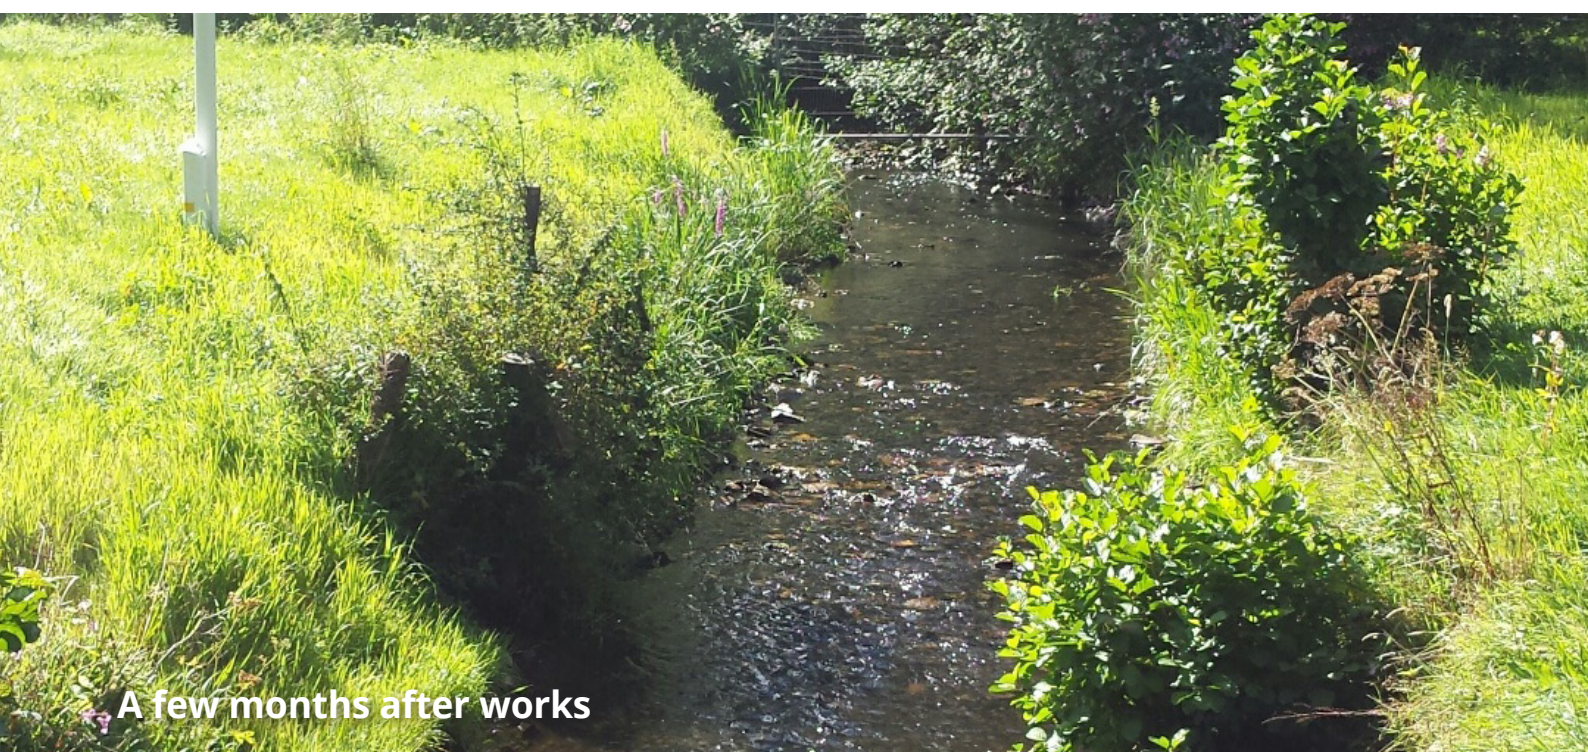
A few months after works
