Roadwater Erosion Protection

Flooding Risk

The River Washford runs through the village of Roadwater near Minehead, Somerset. The catchment creates a flashy river which floods parts of the village in large flood events. The increasing frequency of flood events required the existing system to be replaced and improved.

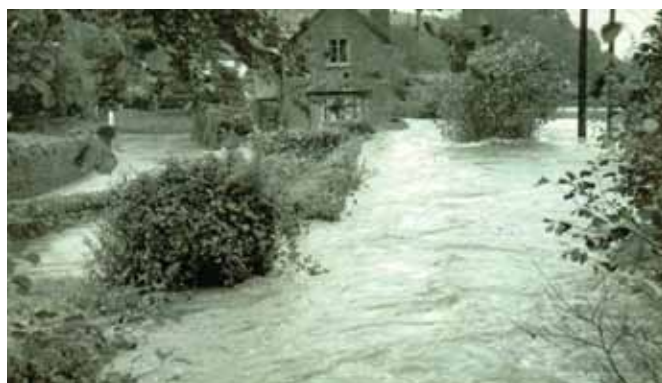
A flood event before the pole piled improvements were made to the river.

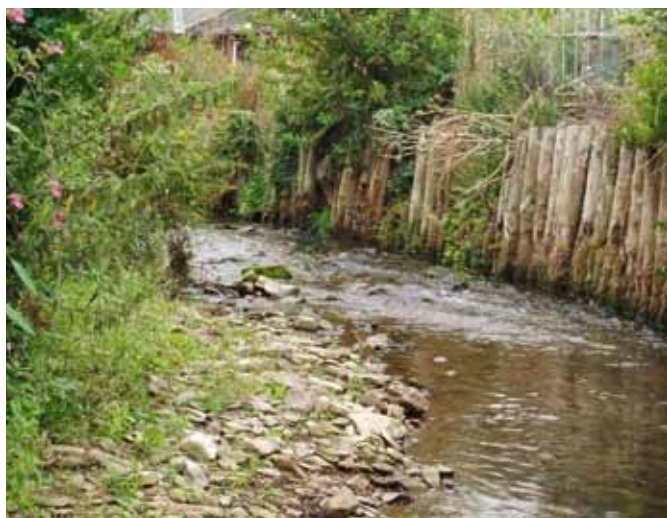
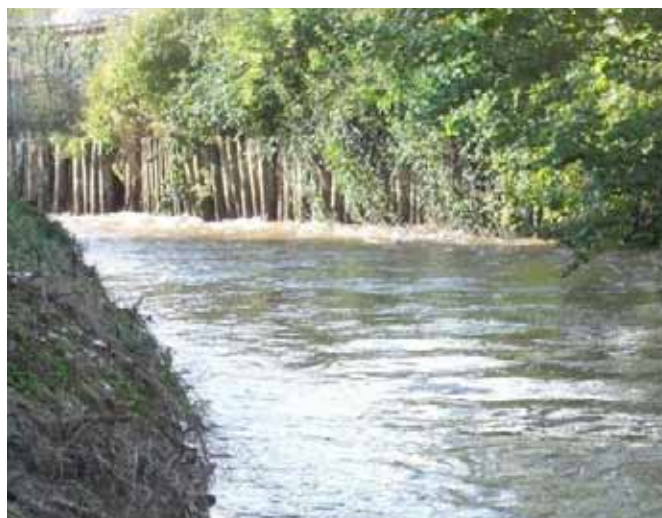
A forty metre section of the river which had timber piled revetment running between properties required urgent attention. These piles were at the end of their working life and new erosion protection was required. The site was constrained on both sides and as such a conventional system was not feasible. Salix was approached by the Environment Agency to offer a design and build solution, in order to provide long term protection to the riverbank, but using bioengineering solutions to ensure that the riverbank was ecologically sensitive.

Photographs above show the original pole piled erosion protection in low flow and moderate flood on 28th October 2013.

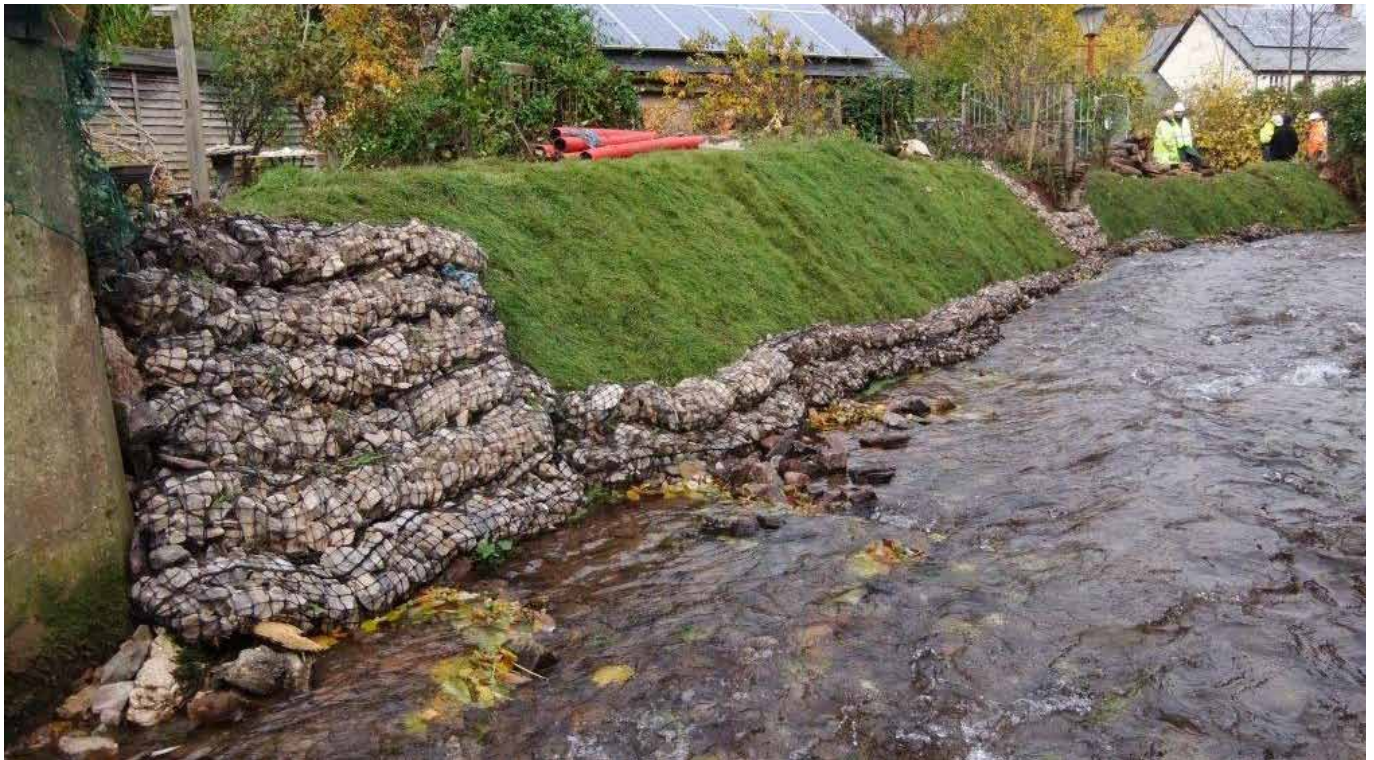
The new system installed after 2 weeks work, in November 2013, gives the river more room for flood events and a sustainable natural slope.

The new bank protection provided a robust toe and a reinforced turf slope. This combination has the required shear stress resistance to the flow during peak flood events. Rock Rolls are 300mm diameter high strength nets ready filled with stone and were used instead of rip-rap or gabions. They were placed to provide "engineering" resistance to flow and also to create natural features with habitat value. They are sewn together where they touch to create one mass, either in line or where stacked up the slope. The pebble bedload was thought to be mobile so site won brushwood was placed around them to slow the water and reduce potential impact. As the slope was so steep and this was a live repair Salix installed "Shear Stress Turf". This is a turf reinforcement mat (TRM) grown off-site and therefore has immediate resistance to 6m/s flow. This reinforced turf instantly provided the required performance in this confined site.

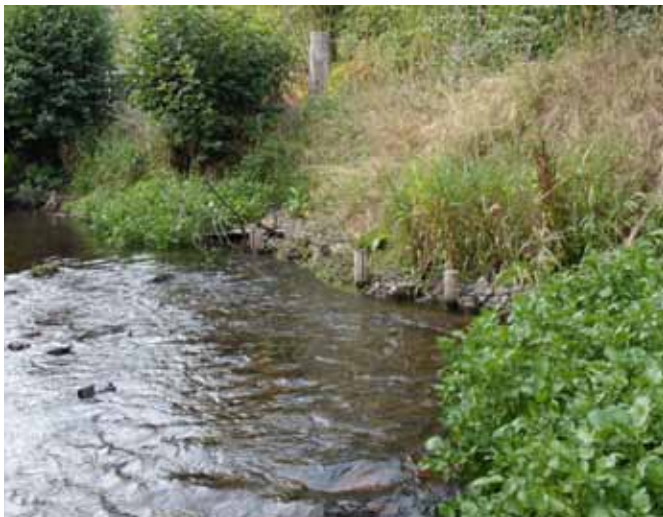
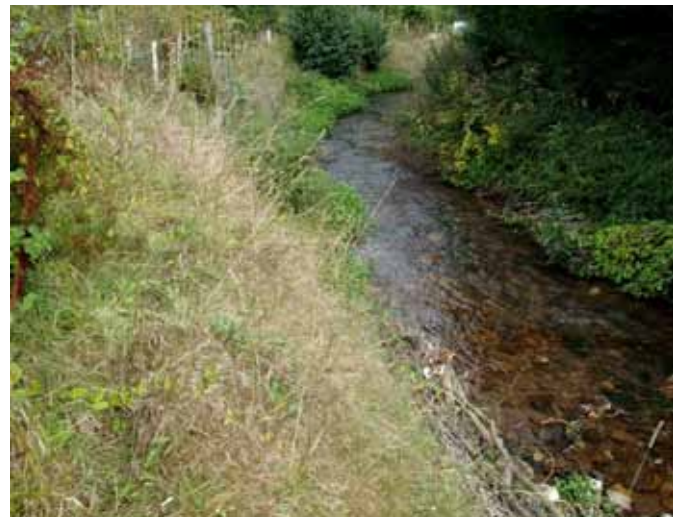
After only 10 months, in September 2014, new in-stream and waterline plants are colonising the new work and the slopes.

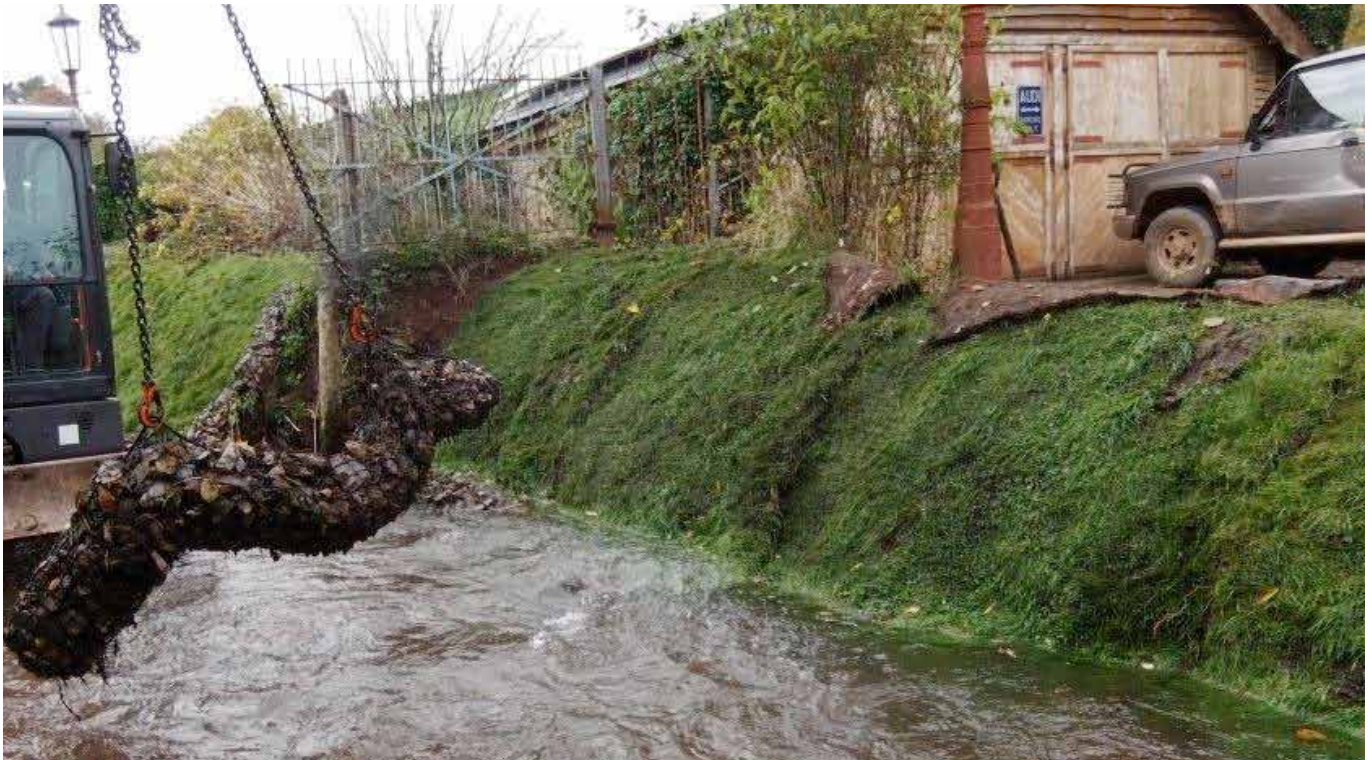
Photographs above show the Rock Rolls which are delivered to site prefilled and were quickly installed into the flowing water. The Rock rolls protect the toe against erosion and anchor the Shear Stress Turf.

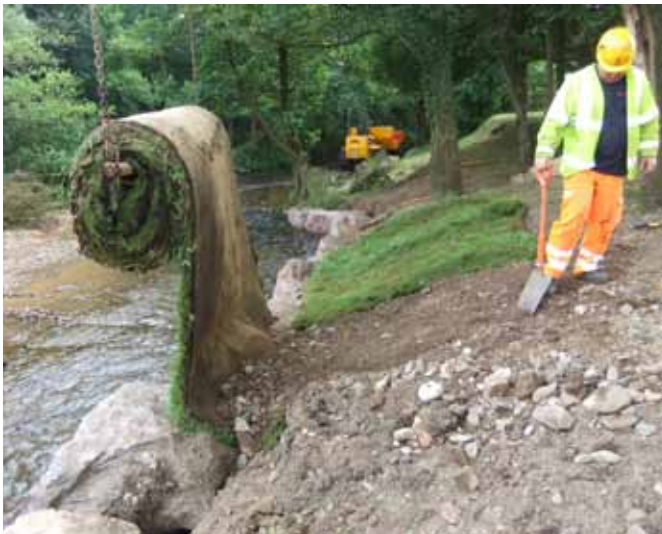
VMax³ Shear Stress Turf provides long term erosion protection and vegetation establishment assistance while permanently reinforcing vegetation. At installation the turf can resist 6m/s flood events.

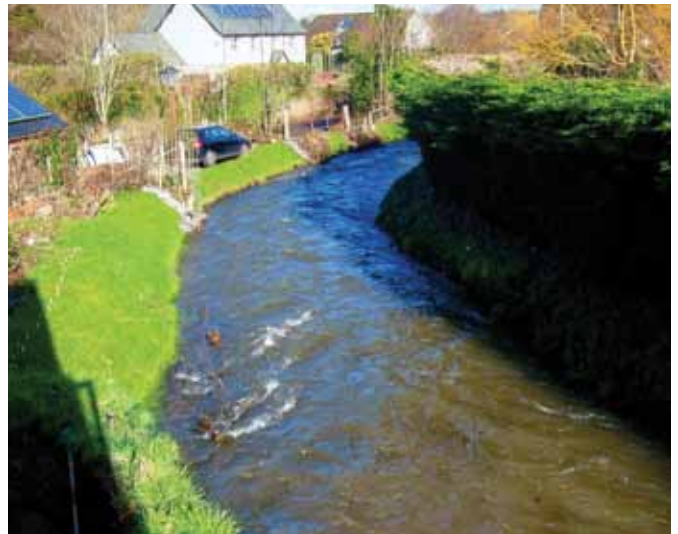
Photograph above taken 10th January 2014 show the new bank intact after a major flood event in only one month after installing the system.

The riparian owner commented that previously in an event of this type the road would have flooded. Kevin Coombes, Flood and Coastal Risk Officer for The Environment Agency commented: "An urgent solution was required and Salix were able to evaluate the situation and resolve the problem within the tight budget."
