Medmerry Realignment Mitigation Work

Salix worked with The Environment Agency and Team Van Oord on the Water Vole mitigation work at the Medmerry Realignment project, West Sussex.

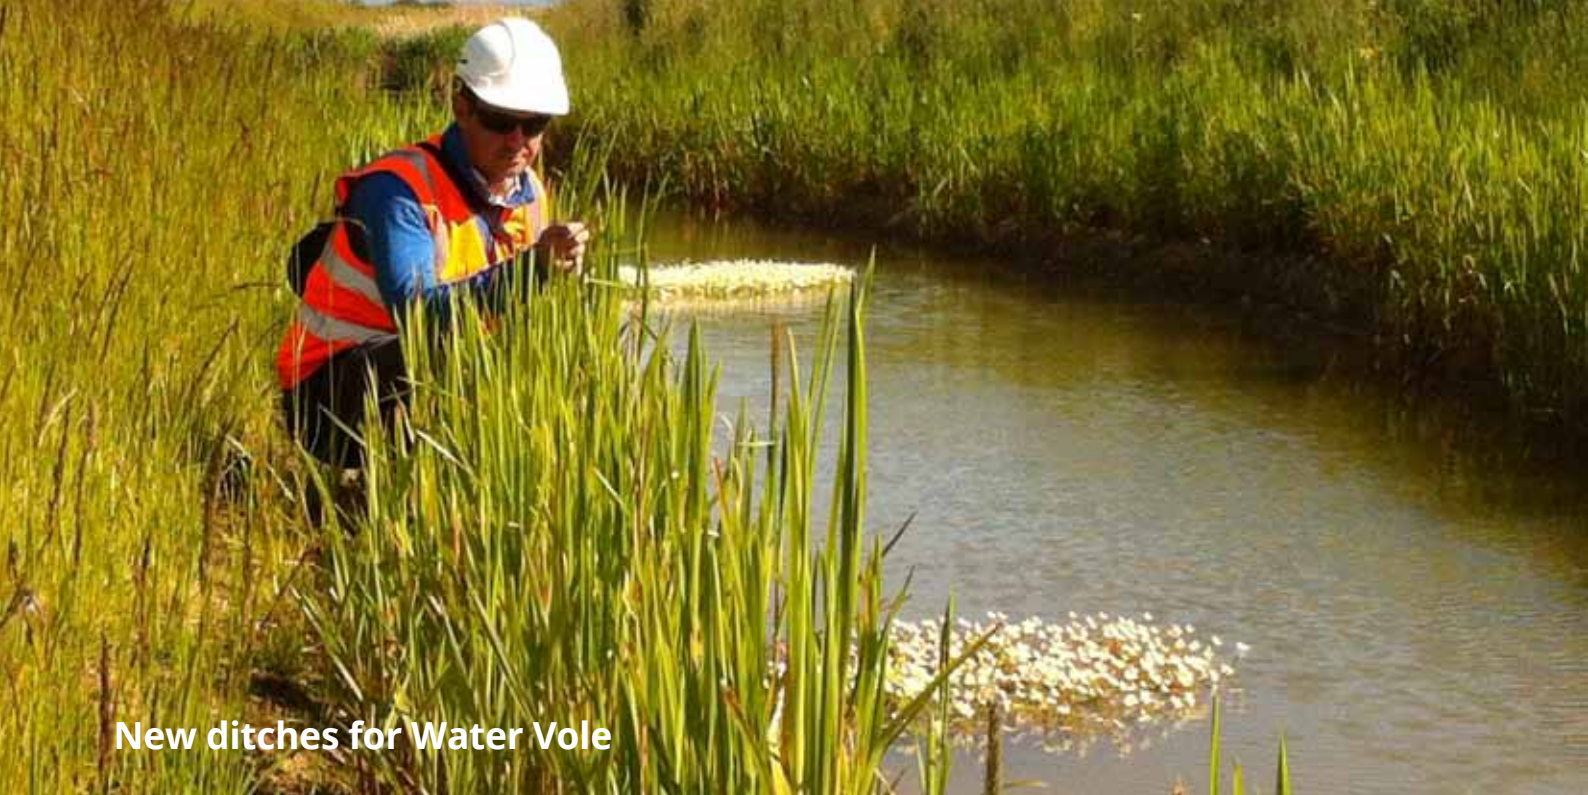
New ditches for Water Vole

Therefore 3171 metres of pre-established Coir Pallets and 3100 metres of high density wetland plug planting was required to make up the shortfall.

2930 metres of vegetation from the centre of existing Water Vole habitat ditches was carefully removed under close supervision. The vegetation was translocated into the newly created ditch network at average water level.

Each particular plant species or community of vegetation was dug at different depths and translocated and placed in the new channel differently to reflect the species specific needs.

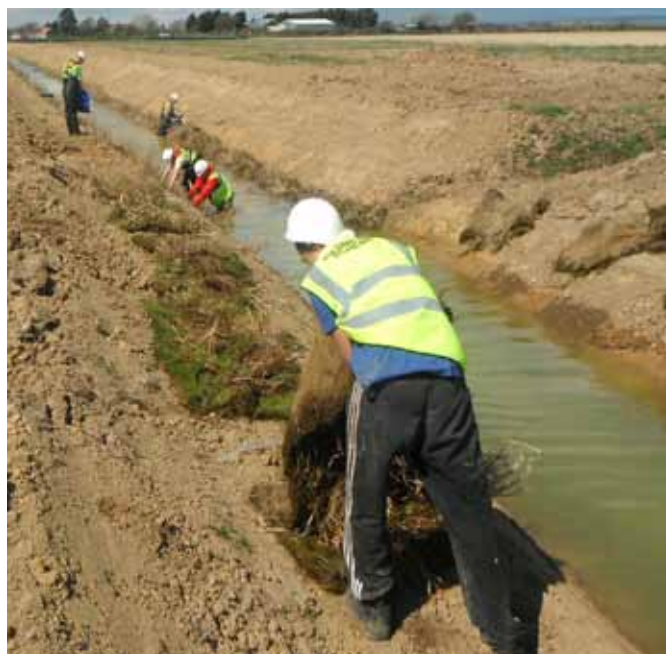
Coir Pallets installed April 2012

The report, written by Rowenna Baker, concluded that areas with pre-established Coir Pallets provided excellent and immediate cover for Water Voles.

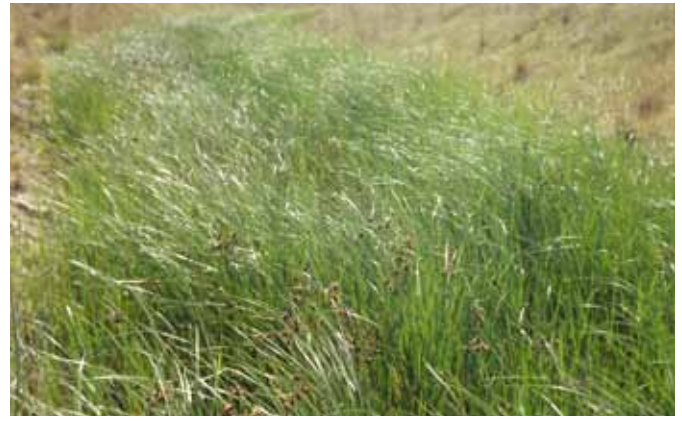
Regrowth in new channel August 2012

The establishment of the translocated material has been a great success with over 3km of new bank habitat to maturity in only a four month period.

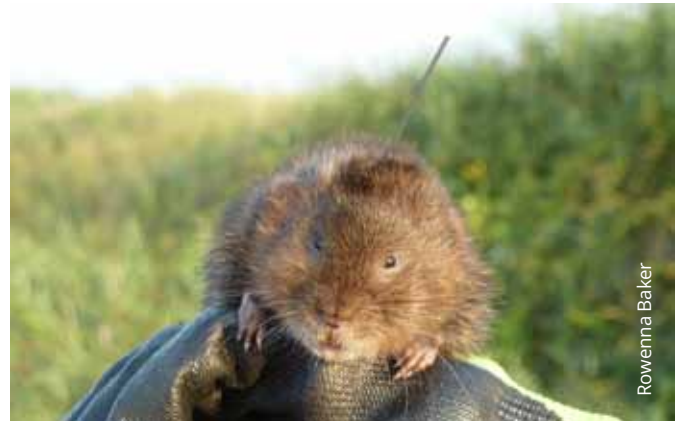
Water Vole are being monitored using radio transmitters

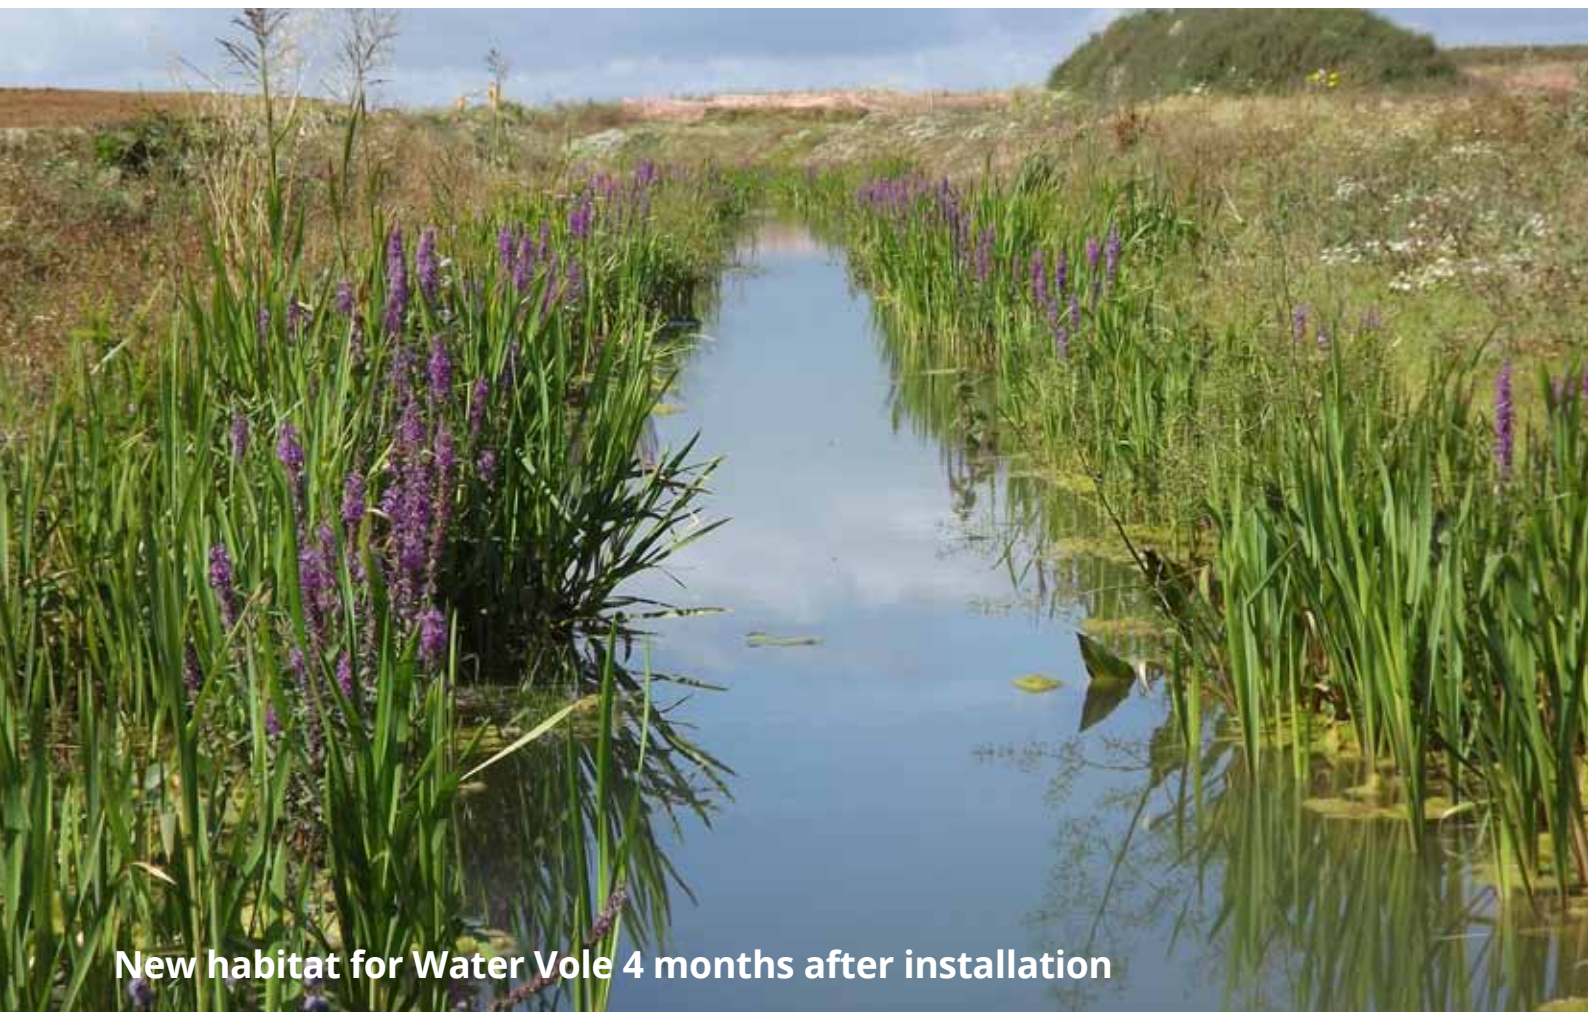
New habitat for Water Vole 4 months after installation
