Erosion Management at Wisley Golf Course

This project involved extensive works to the River Wey, which flows through three holes of The Wisley Golf Club.

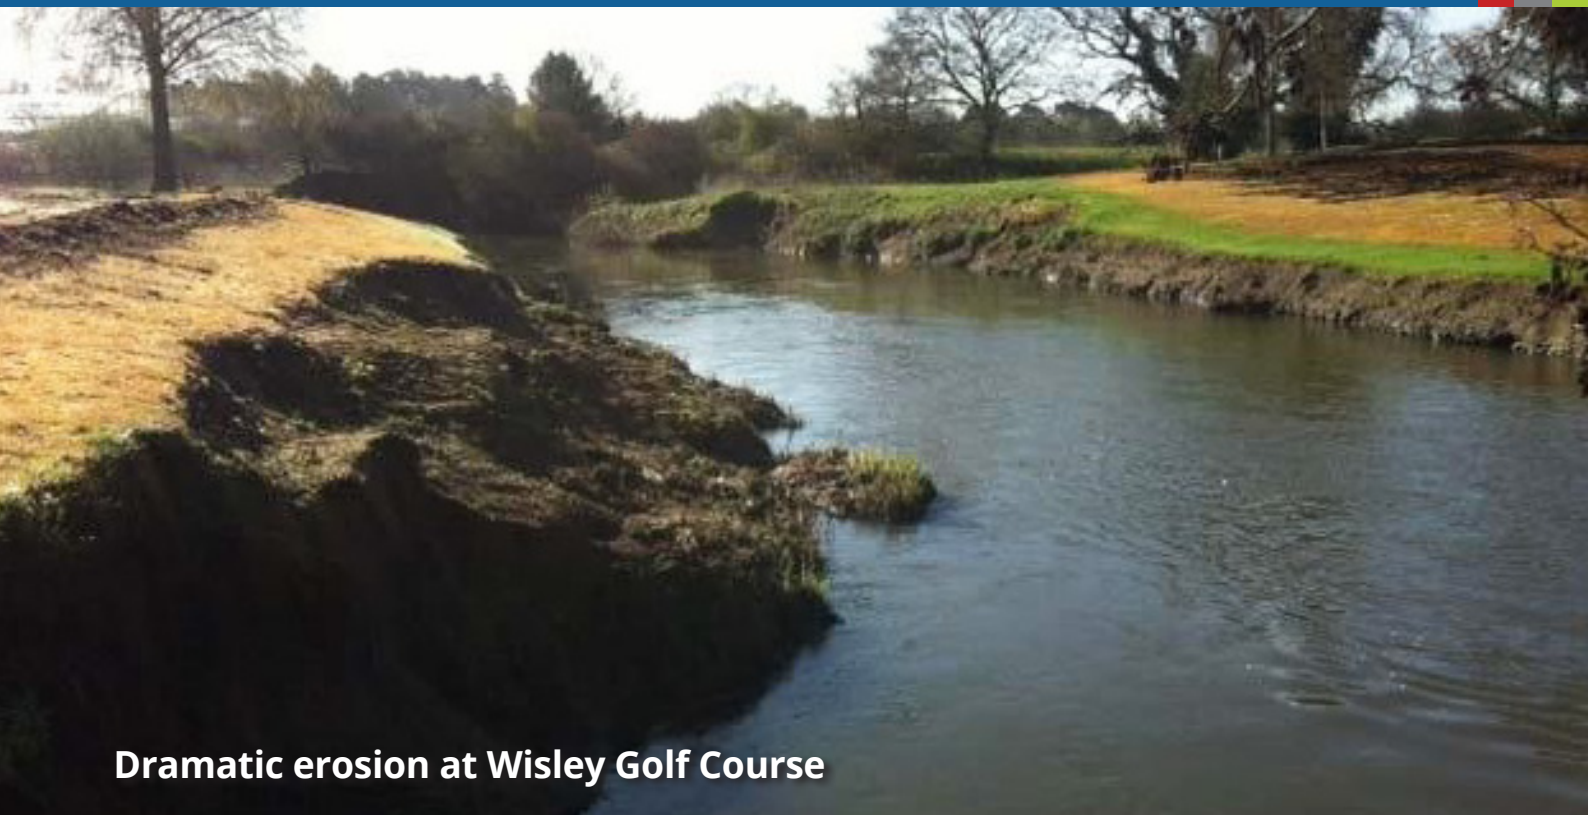
Dramatic erosion at Wisley Golf Course

Years of erosion had taken its toll, leaving unstable vertical banks two to three metres high.

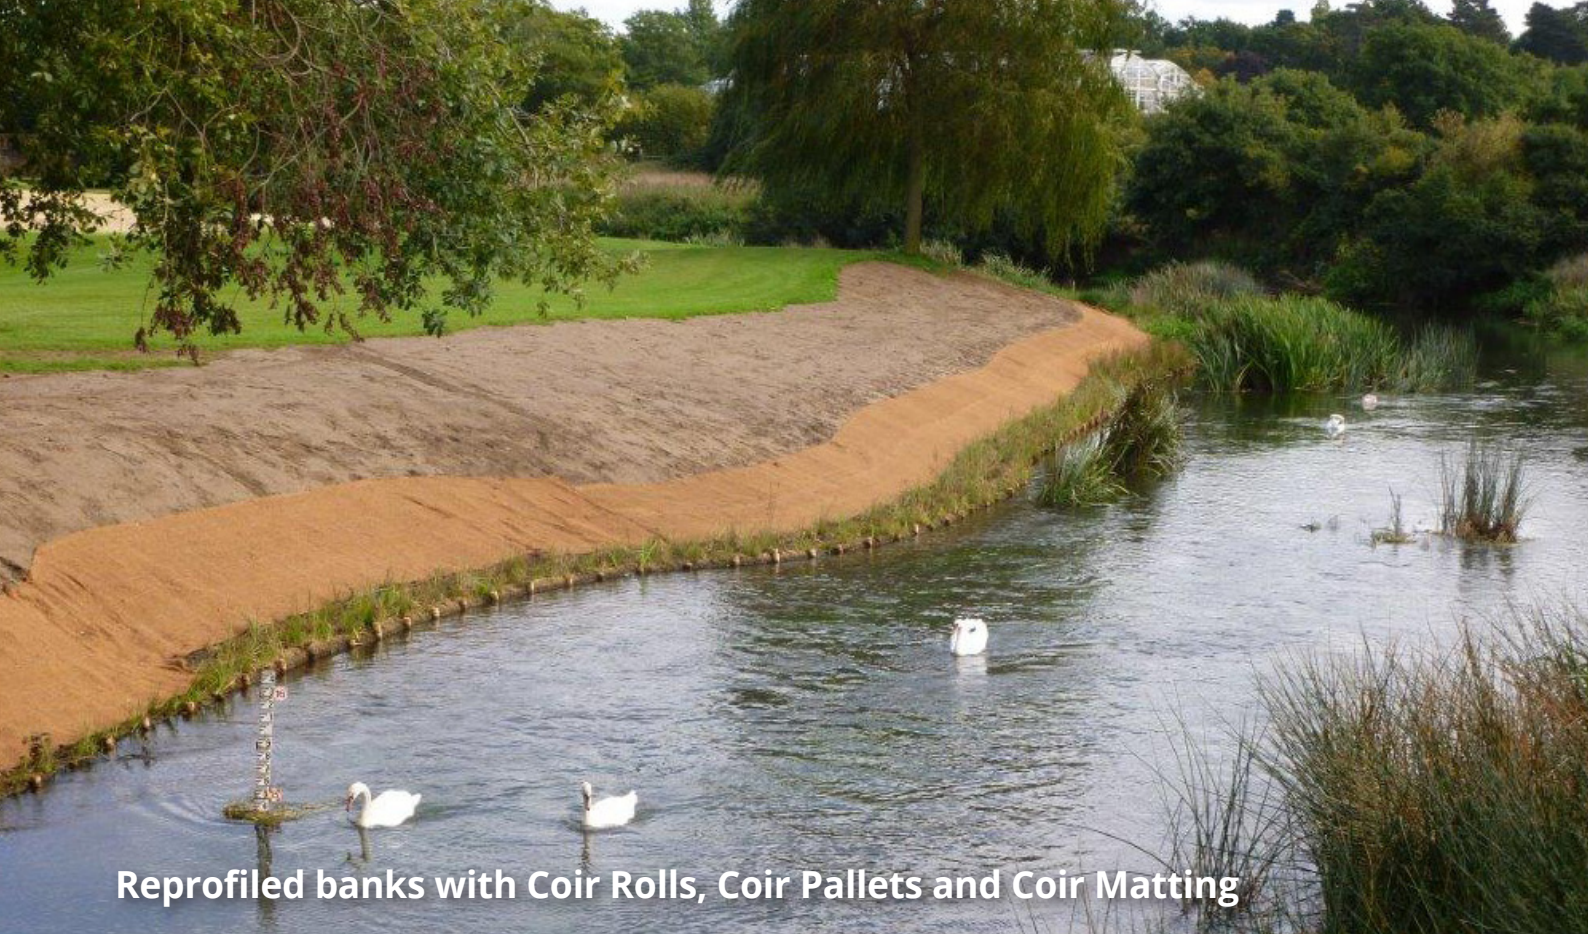
Reprofiled banks with Coir Rolls, Coir Pallets and Coir Matting

Firstly, the banks were graded back and informally shaped, creating angles of between 20 and 25 degrees.

Coir Rolls containing well-established plants were installed, with two thirds submerged below mean water level.

A shelf was then formed at water level and pre-established Coir Pallets, with mature varieties of indigenous plants, were carefully positioned.

Both the Rolls and Pallets were staked and tied as a temporary measure to prevent movement until the plants had sufficient time to establish a robust root system.

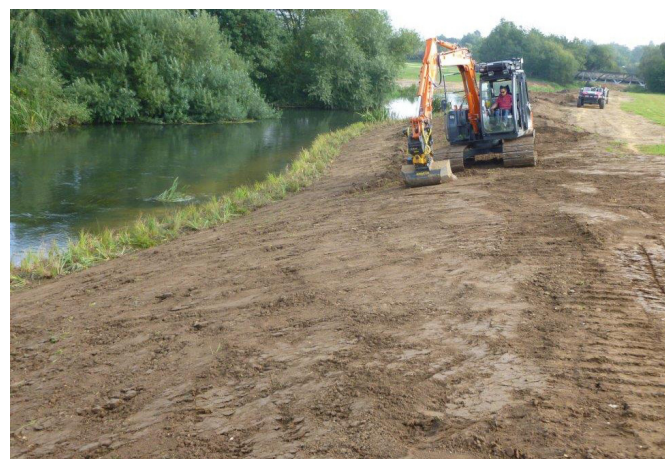
Reprofiling the river bank

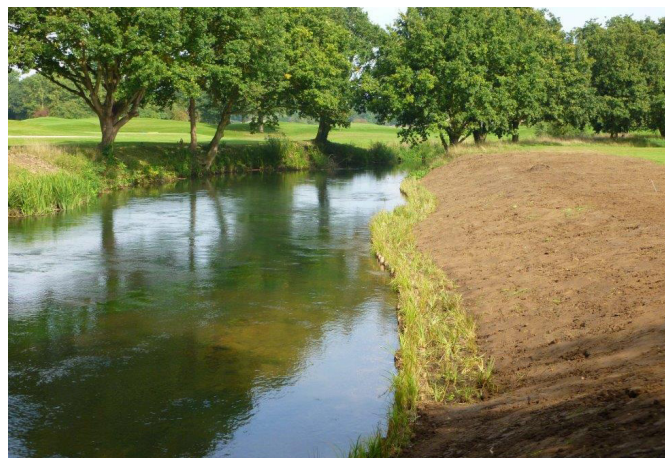
Preplanted Coir Rolls provide immediate bank protection

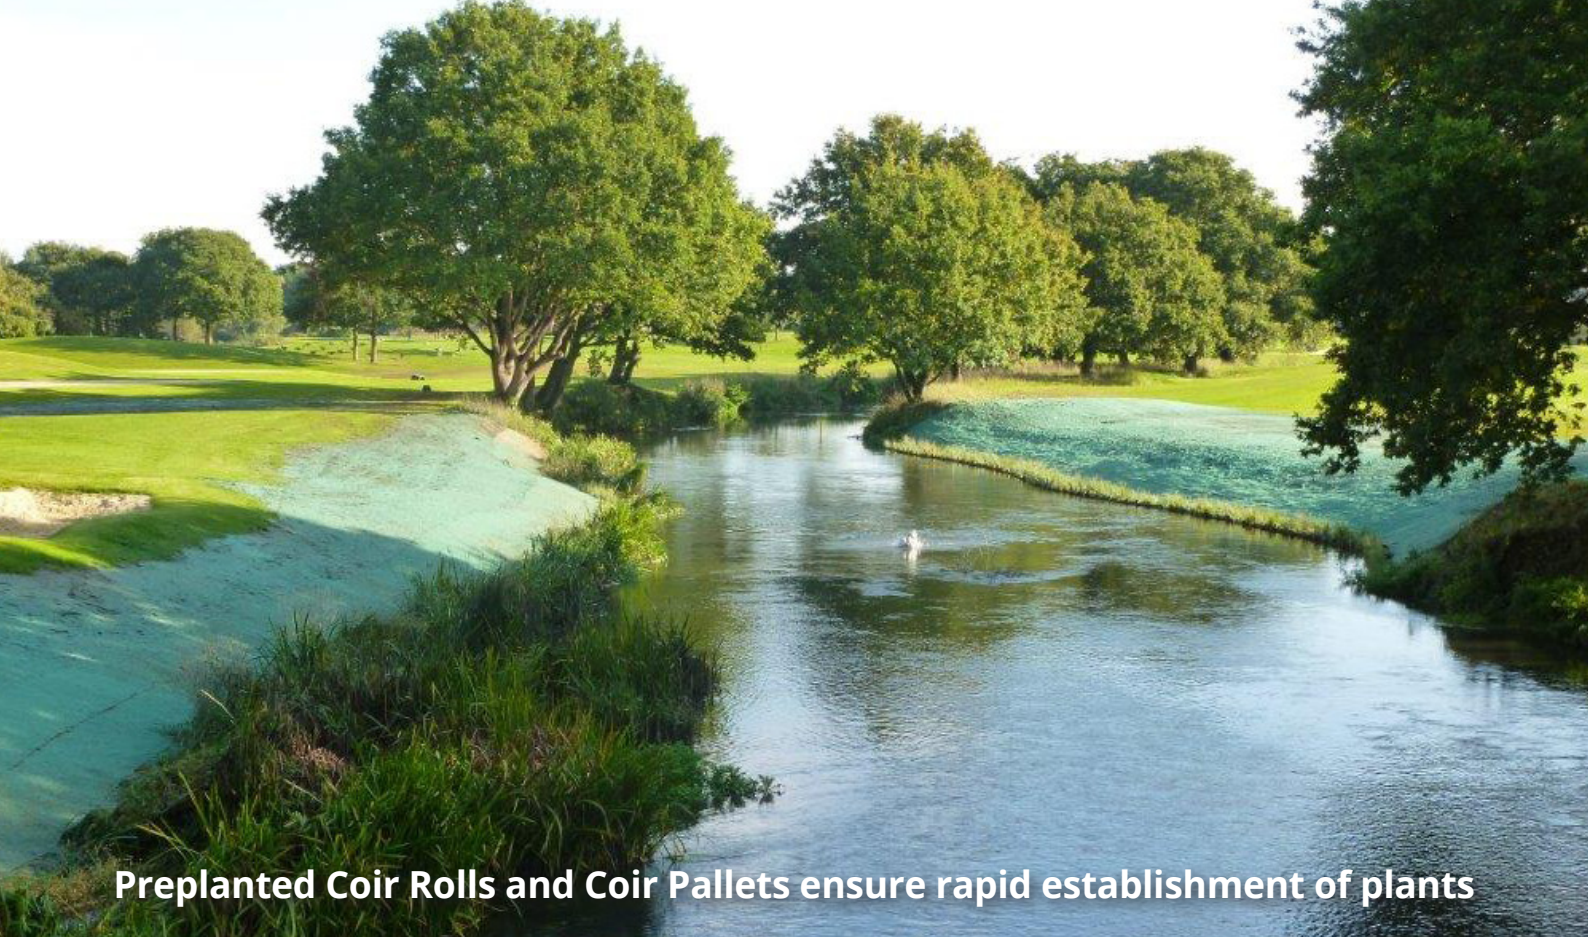
Preplanted Coir Rolls and Coir Pallets ensure rapid establishment of plants

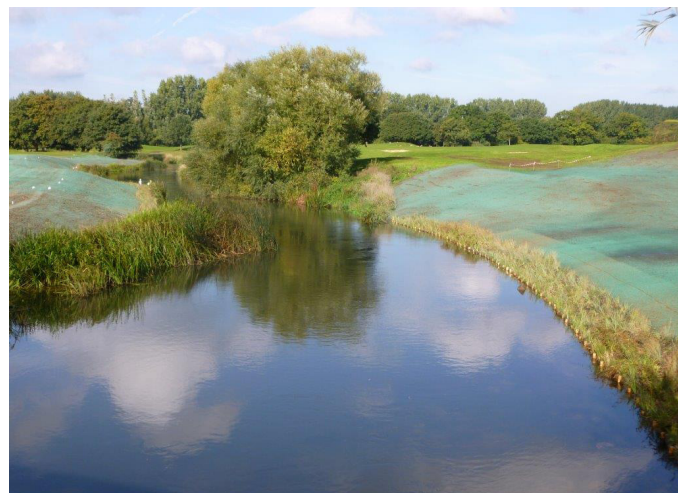
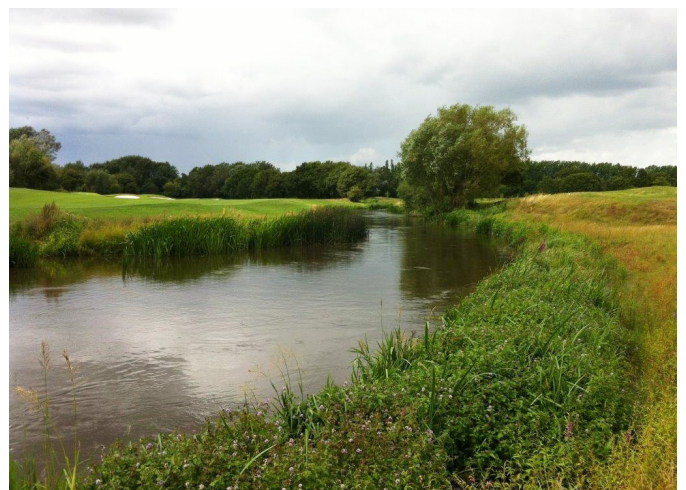
Well established plants and robust natural erosion control

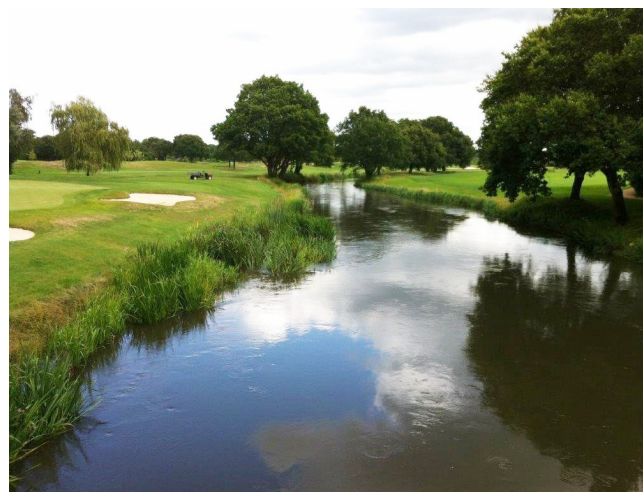
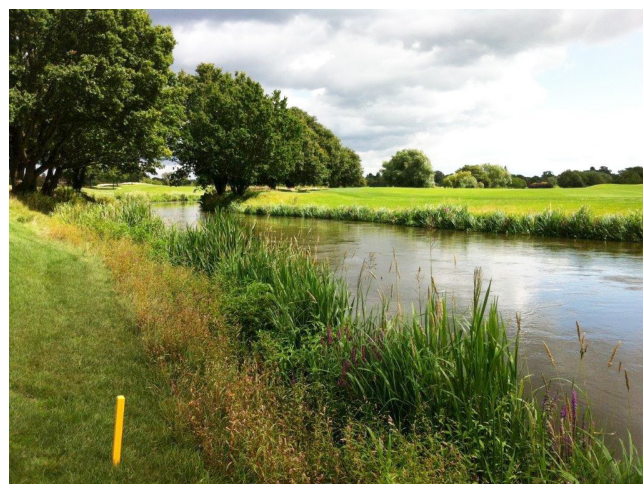
They successfully withstood the flooding and The Wisley Golf Course now has a stable, fully vegetated river bank that provides safety and beauty for its golfers.
