Worden Park Leyland

PROJECT NAME :	Worden Park
CLIENT :	South Ribble Council
LOCATION :	Lancashire
PROJECT CATEGORY :	SUDS and Drainage Channels

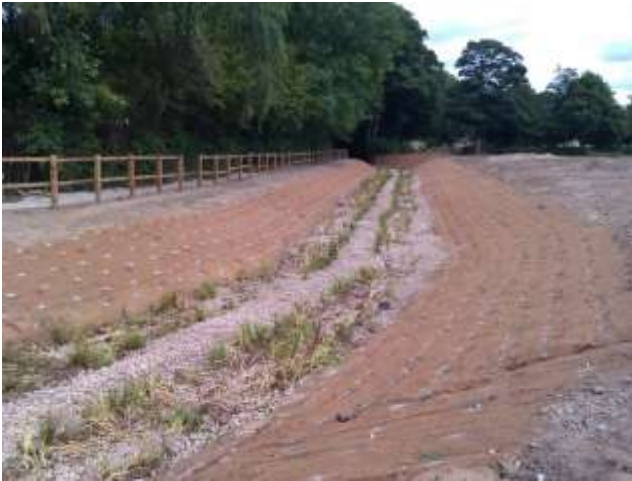
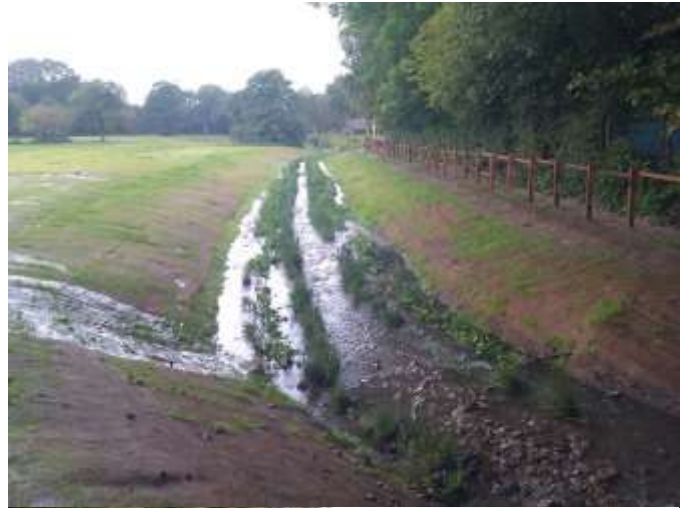
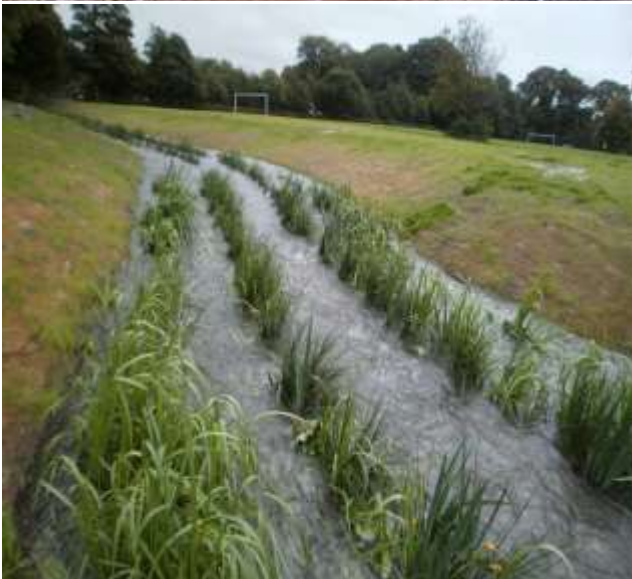
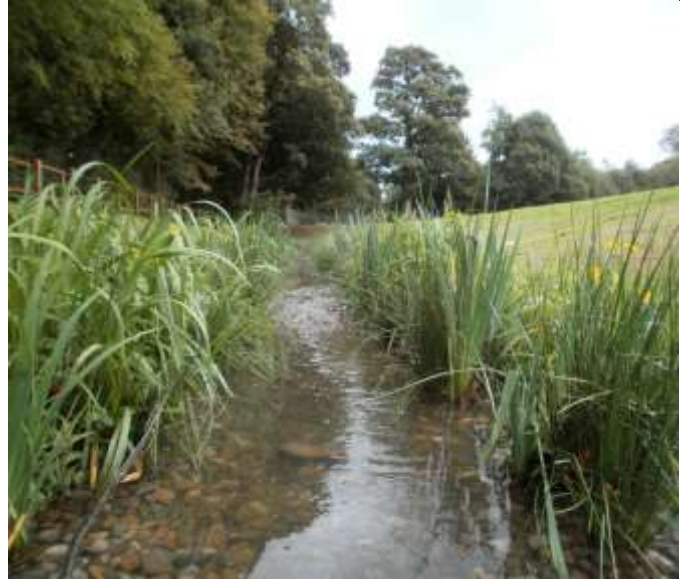
The above images illustrate the early stages of our work on site through to how the finished scheme appears today-the pre-established coir rolls are now mature.

The pre-established coir rolls and pallets all began putting on new growth within a matter of days providing the watercourse with instant channel vegetation and protection to the toe of the banks.

The Nag reinforcement used to stabilise the banks has also prevented any erosion to the sandy soil beneath and has allowed the rapid establishment of grass which wouldn't have otherwise been possible.”
