Revetting and Supporting River Banks

4.8 Bank protection using root wads

RIVER DULAIS

LOCATION – RHOSMAEN, LLANDEILO, CARMARTHENSHIRE SN645243

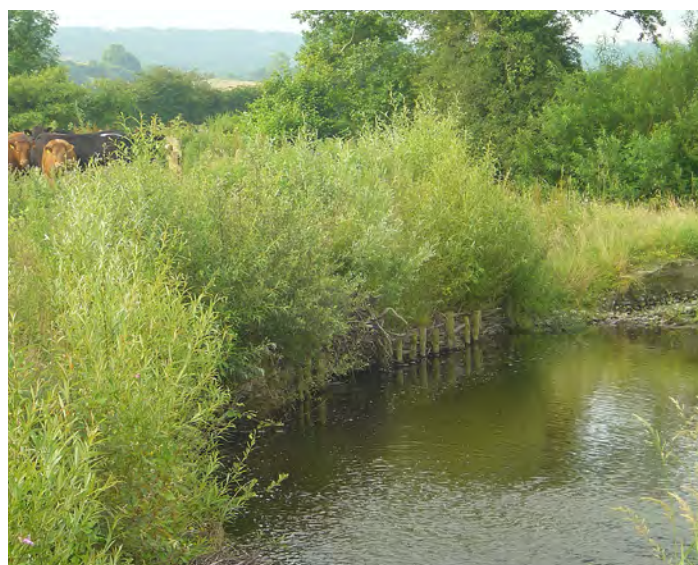
Growth of root wads along bank two years after installation. Brushwood protection can just be seen between root wad growth – 2006

In some areas additional brushwood protection was needed in between the root wads. Careful thought was given to creating a smooth profile along the bank to reduce the risk of erosion. The riverbank above each root wad was protected by erosion control matting.

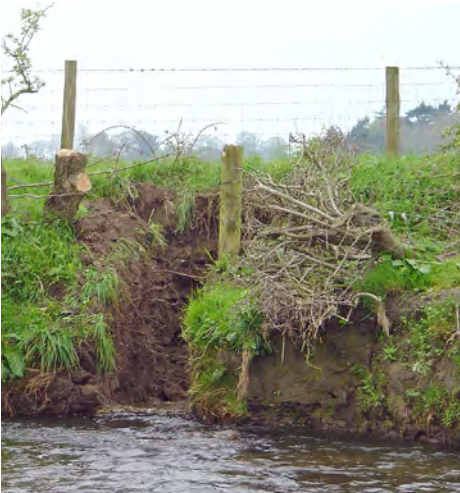
© Salix Trench excavated in bank – 2004

- 1 Where banks were more than 0.5 metres high they were re-graded to a more stable profile

Once root wad centres were identified a trench was dug into the bank, with attention given to the interception angle of the root wad and the flow, as well as the position of the root plate in relation to the bed

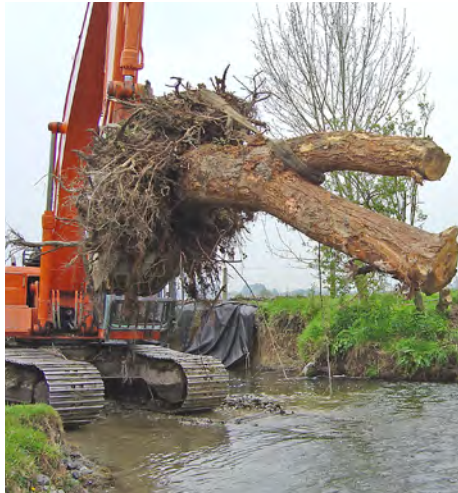
© Salix Excavator moving root wad into position– 2004

- 2 Each root wad was installed to face upstream at a 10 to 20 degree angle to the flow

Installation took place from upstream to downstream so that the angle of each root wad can be "eyed in" after judging the best fit with the upstream root wad

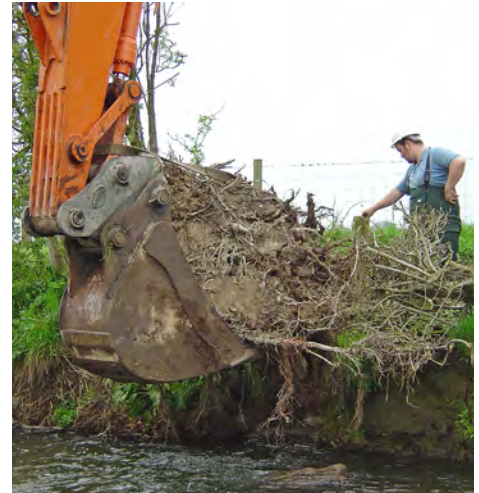
© Salix Installing root wad in bank– 2004

Backfill of each root wad should be well compacted over the anchor trench

As a simple guide each trunk was embedded 3 to 4 times the diameter of the root wad

Spacing of root wads set to 3–4 times the diameter of the rootplate

- 3 With no published guidance, expert opinion was used to finalise spacing based on visual impact of flows

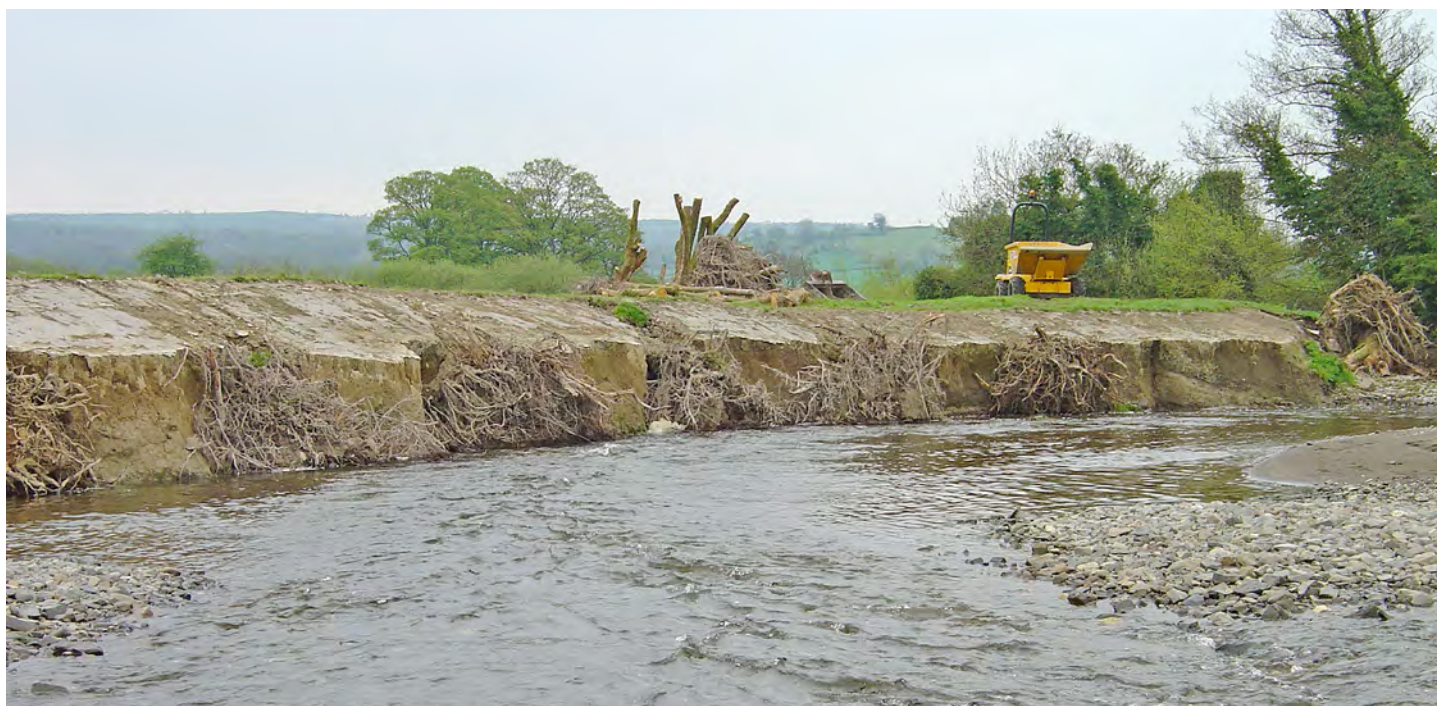
Figure 4.8.2

PLANFORM SHOWING INSTALLATION METHOD FOR ROOT WADS

Each root wad needed to pick up the flow and direct it to the next root wad, avoiding other areas of the bank or bed

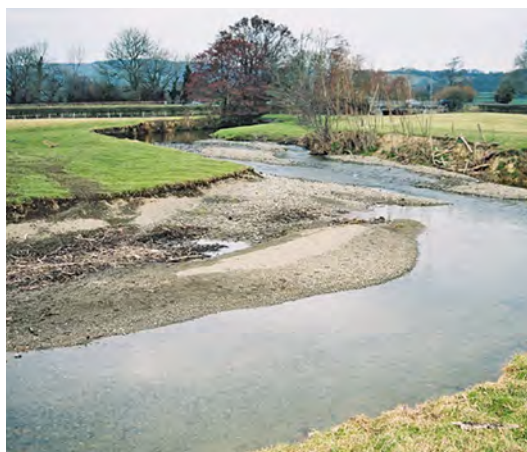
Over-wide eroding channel before restoration – 2003

The River Dulais (Afon Dulais) is a tributary of the River Towy, and is an important spawning habitat for migratory fish. The river had a history of instability and planform adjustment, with a channel cross section up to fifty per cent wider at this location than upstream reaches. Unrestricted grazing, by sheep and cattle, had resulted in a loss of bankside vegetation.

This had reduced cover for fish and increased erosion, causing bank and bed instability. Coarse gravels were covered with a layer of fine silt deposits. For a period of three years the Environment Agency Wales (now Natural Resources Wales) worked with local landowners to fence off 4.9 km of the River

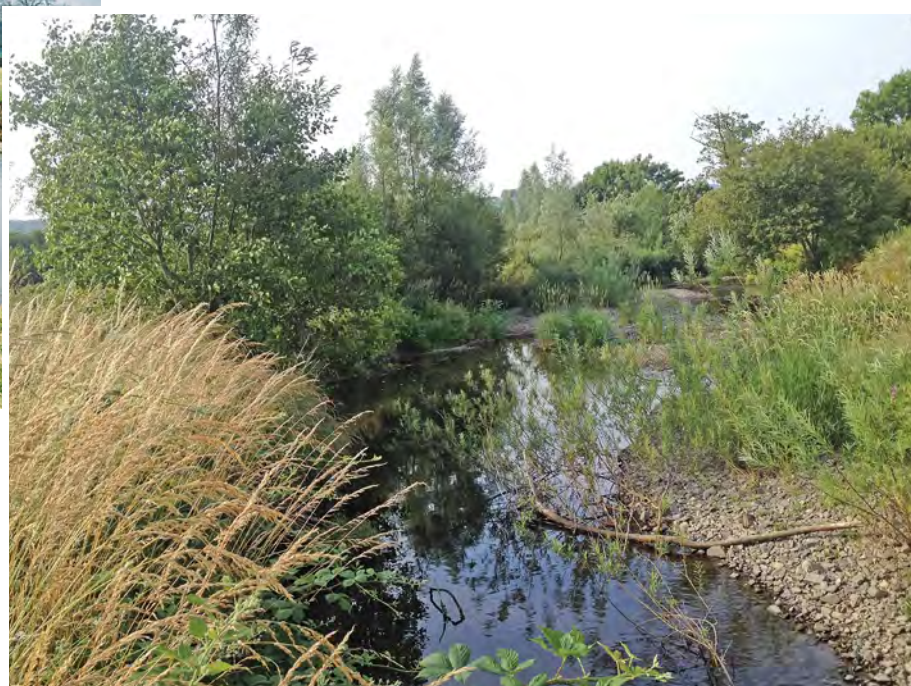
Root wads have become established, stabilising the bank and reducing erosion – August 2013

Stabilisation of a complex outer meander bend has been achieved and each of the root wads installed has grown well.

Where flow is focussed directly at the root wads, an area of localised scour has formed under the base of the exposed root ball. This provides an overhanging vegetated bank, which is a valuable new habitat feature.

Diverse bankside cover has established and cleaner gravels are present, with visibly less fine sediment. Overall the channel geometry is now similar to more well vegetated reaches of the river.
