NATURE IMPROVED

David Holland highlights the benefits of combating high flow erosion with 3-D turf mats

Protecting homes in the Conwy Valley

Fighting erosion on the River Ebbw

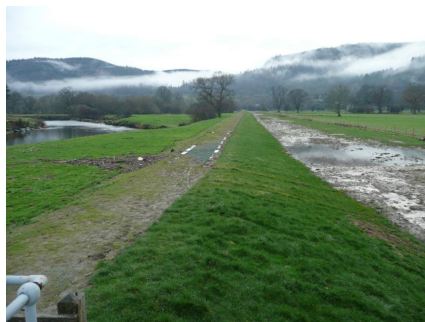
Salix supplied 9,000 square metres of VMax³ shear Stress Turf as part of the Conwy Flood Alleviation Scheme. The grass remained undamaged after a subsequent major flood event with an estimated flow velocity up to seven m/s flow.

Salix was contracted to supply and install 9,000 square metres of VMax³ Shear Stress Turf for the project, grown using P550 with a specified grass mixture to provide instant vegetative erosion protection on the lowered flood defences. P550 within the turf offers permanent reinforcement, increasing the power of vegetation to withstand high velocity flow regimes of up to 7.6m/sec.

The turf on the spillway was put the test when the area was hit by heavy rain just two months later in November 2009 and experienced the worst flooding in 25

All parties concerned were impressed with the performance of the product, with Team Van Oord project manager, Matt Phillips, stating: 'The pre-grown P550 performed very well during a significant flood event. There was no flood damage to repair on the banks protected by the P550.'

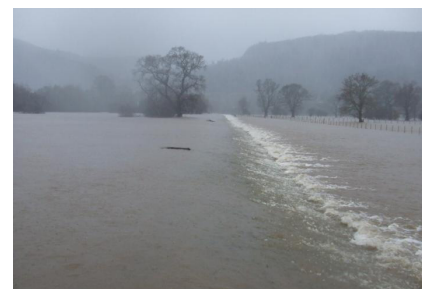
V-Max P550 after a five-hour over topping event with flow velocities modeled at seven m/s flow. There was no recorded damage to the vegetation layer and no soil loss.

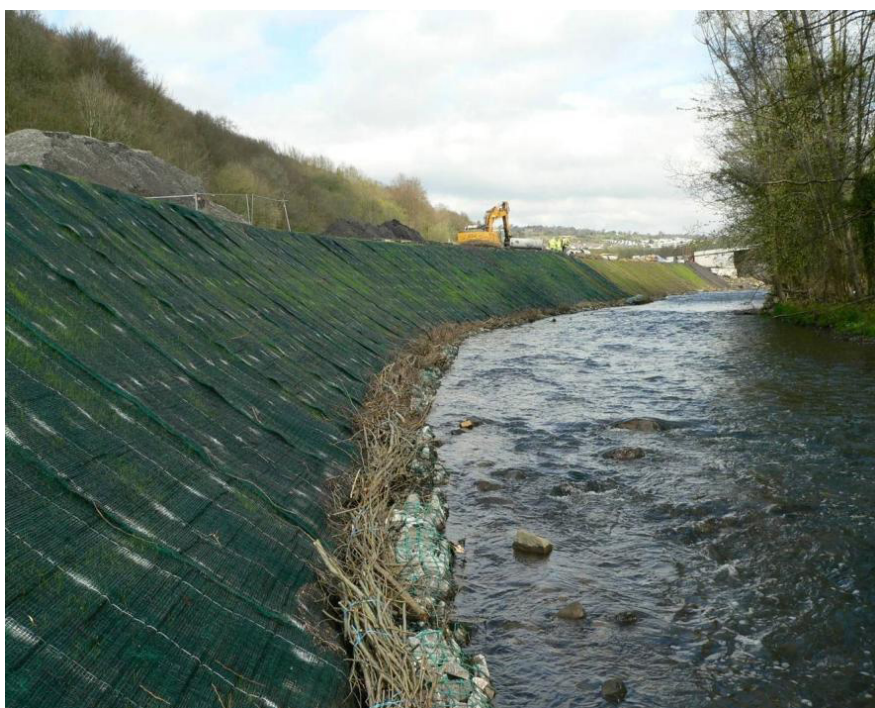
River Ebbw during installation of V-Max P550 and Rock Roll/Fascine Toe

ON THE RIVER EBBW at Risca in South Wales, Salix worked with Merrimans Ltd to stabilise over 1.2 kilometres of steep 1-in-1.5 riverbank, composed of highly erodible colliery shale.

To provide underlying stability, as well as an ecological resource, the toe of the bank was protected using a combination of rock rolls and living willow fascines. The upper bank was

protected using two high performance erosion control mats, VMax³ P550 and VMax³ C350.

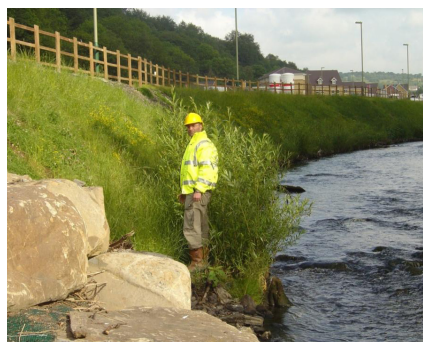
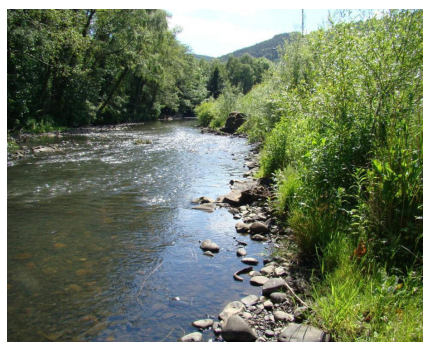
Top: Establishment after one year. Note the blockstone actually failed here
Above: The TRM reinforced vegetation after ten years.

The project has withstood well against the test of time and delivered excellent ecological benefits. The riverbanks now look completely natural and although there's now no sign of the rock rolls or TRM, these materials are working hard, reinforcing and stabilising the vegetation layers above.

Some blockstone was installed on one reach and it is fascinating to see that ten years on it is the three-tonne blockstone that is failing and not the reinforced vegetation.
