## Railway Lane, Lewes

The Environment Agency are responsible for the river bank stability at Railway Lane, Lewes. The integrity of the existing blockwork facing was deteriorating as a result of the tidal inundation and draw-down cycles together with areas of groundwater seepages emanating from the slope profile.

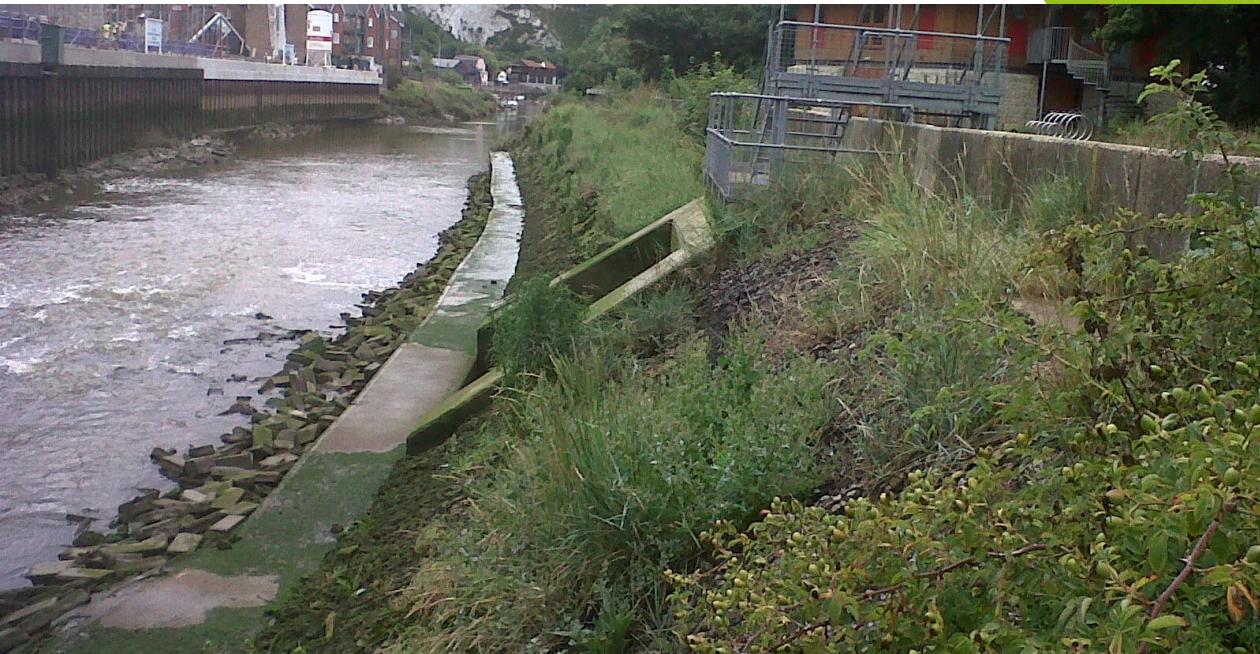
The integrity of the existing blockwork facing was deteriorating as a result of the tidal inundation and draw-down cycles together with areas of groundwater seepages emanating from the slope profile.

The Salix Rock Mattresses are all butted and mechanically stitched together with “hog rings” so as to form one continuous flexible revetment.

The pore-water pressure from the profile can be released through the fabric and porous rock sheet.

As the tides flood over the surface and retreat, so the engineered appearance will moderate with the accreting sediment that will lodge in the stone interstices.
