River Elwy, Pipeline Protection, North Wales

Pipeline Protection

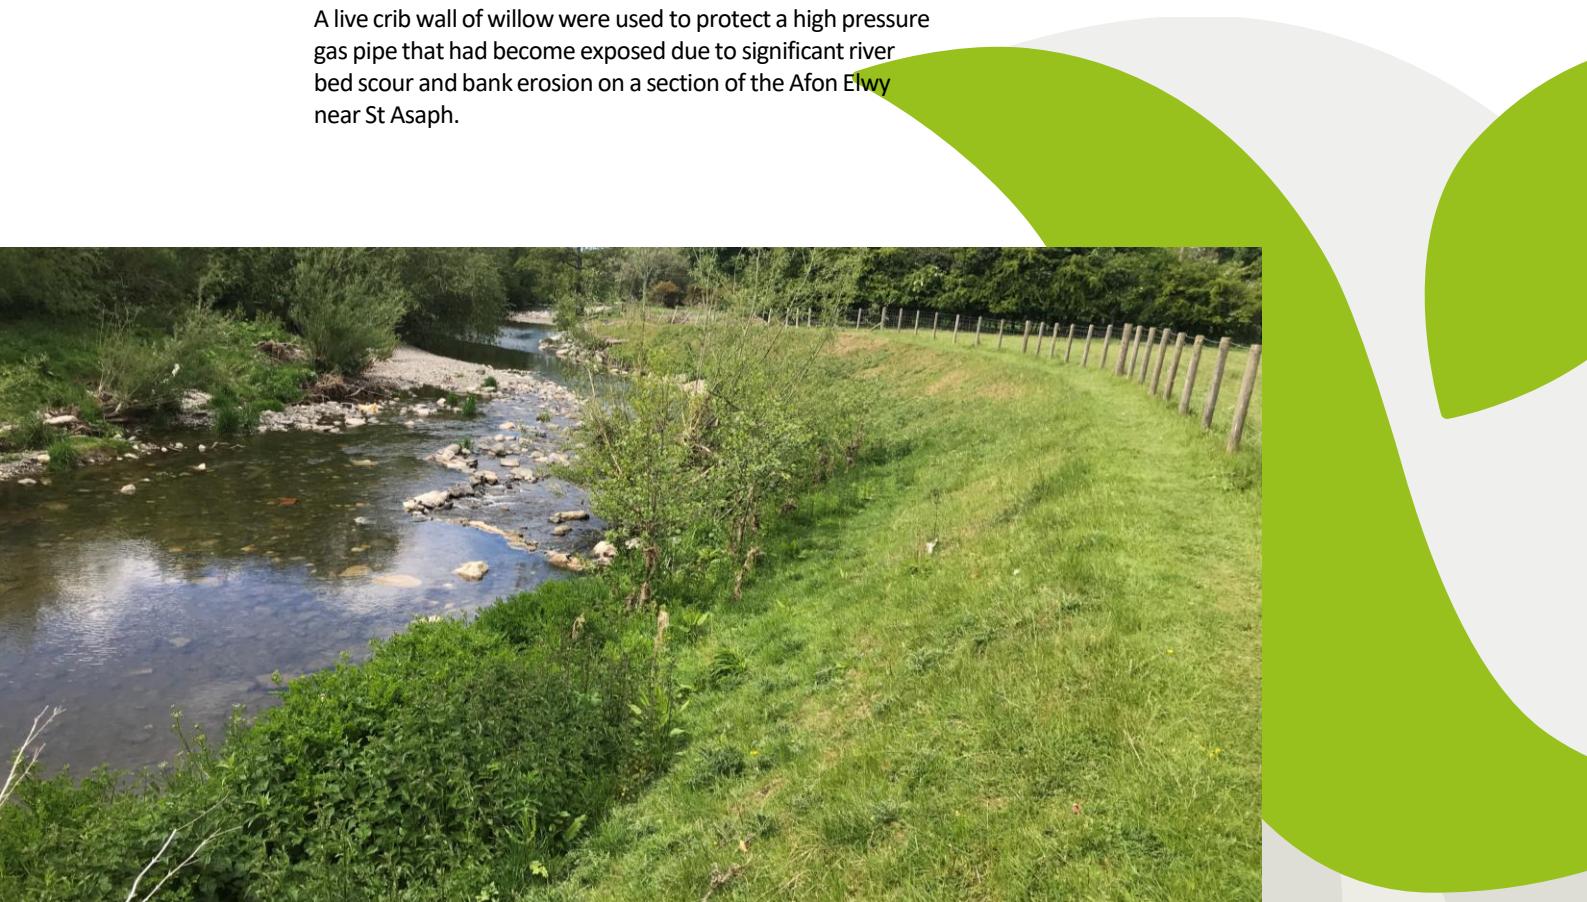
A live crib wall of willow were used to protect a high pressure gas pipe that had become exposed due to significant river bed scour and bank erosion on a section of the Afon Elwy near St Asaph.

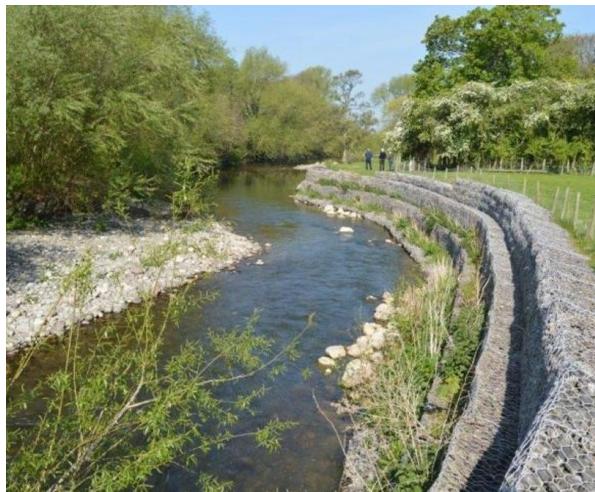
The last few gabions have an area of scour in behind them.

Existing conditions modelling showed two mechanisms for erosion on the right bank: at all flows there is an area of recirculation with appreciable reverse velocities on the right bank downstream of the gabions; at high flows there is a fast moving downstream jet of flow from over the top of the gabions and in behind them into an obvious area of erosion.

The gabions jut out into the flow and enforce a left turn, and as the gabions end, the flow separates with a shear layer, expands considerably, and causes the recirculation. The proposed design was to remove the gabion structure and re-grade the right bank.

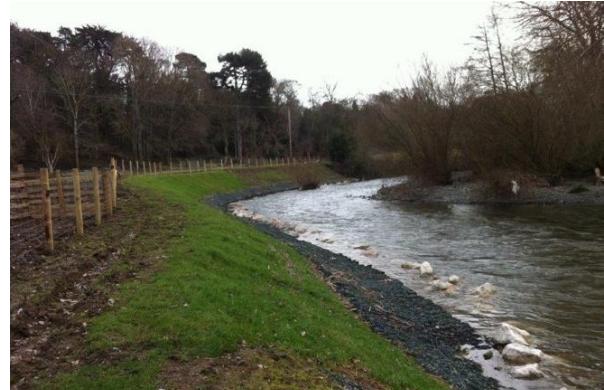
Works were undertaken to remove the large 4m high gabion structure. Stone from the gabions was used to partially fill in the

large scour pool that had exposed the gas pipe.

Removing this structure gave the channel more room and dissipated shear stress over the pipe. Works were undertaken using Salix's Menzi Muck spider excavator due to the limited access and steep banks .

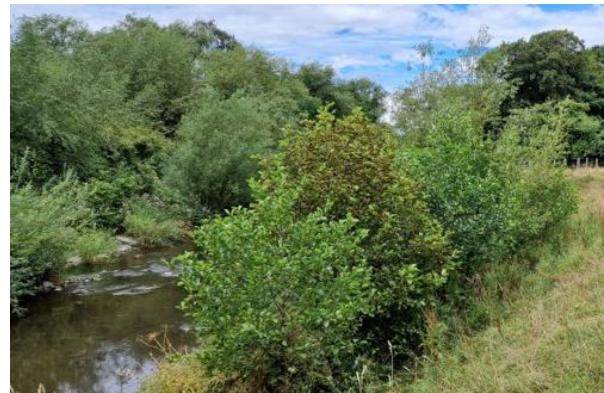
Directly over the pipe the area of eroded bank was build back up using an innovative large wood and live crib wall design.

Construction of the live crib wall with large rootwads. The tree roots slow the flow locally in flood events and provide shade and shelter for aquatic life

This would ensure that the most robust bioengineering technique would provide structural integrity over the pipeline but also slow the flow and allow native bankside habitat to develop.
