River Thaw Enhancement

Salix were asked by Environment Agency Wales to advise on methods to restore a 100 metre reach of the River Thaw which had been subject to physical degradation by overgrazing and cattle poaching.

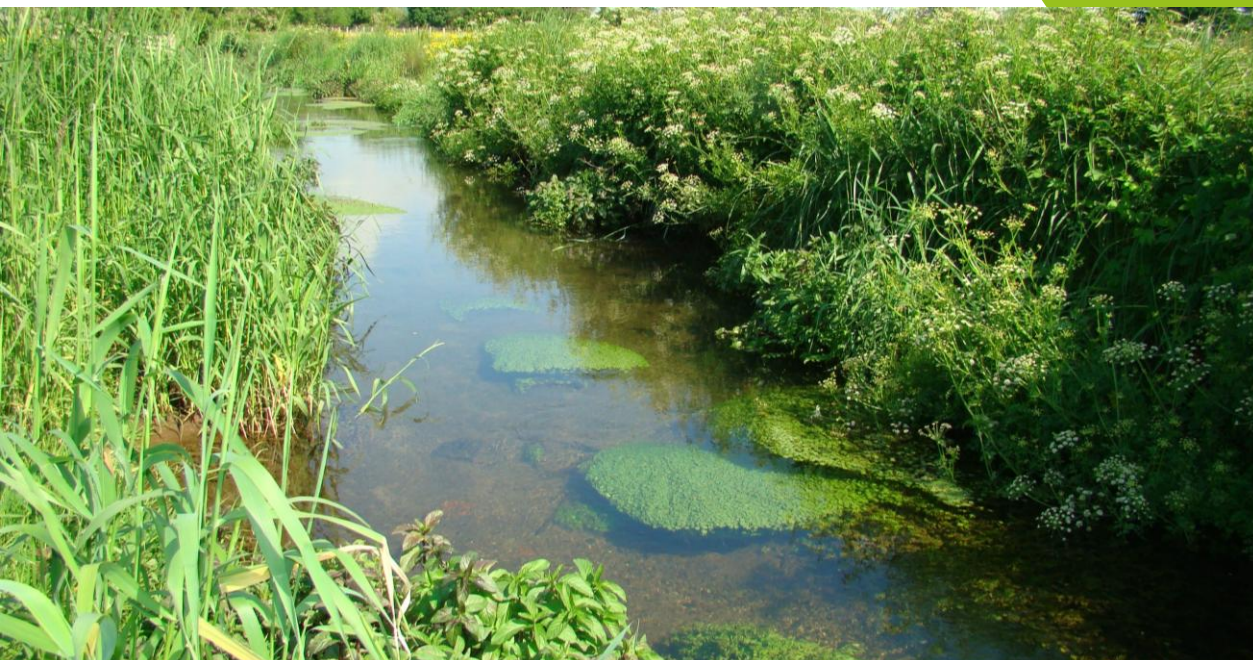
Salix conducted a basic walk over survey and concluded that the degraded reach was 25-30% wider than unaffected reaches up and down stream. The over wide channel had lost much of its physical habitat value due to the poaching.

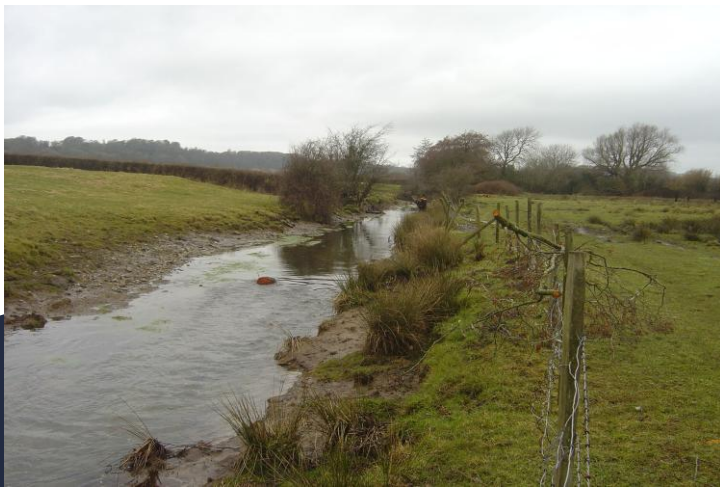
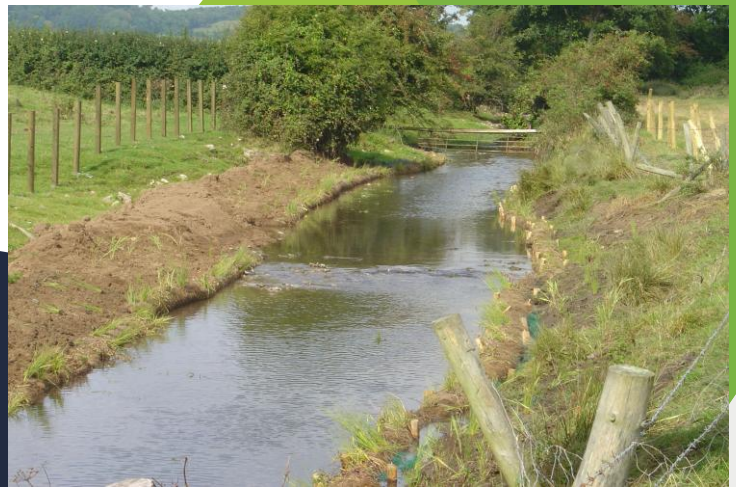
This has allowed submerged vegetation to re-establish and provide excellent physical habitat structure within the channel.

The pre-established Coir Rolls have rapidly controlled bank erosion and have provided a physical habitat with the diverse vegetation establishment of marginal and bankside species.

Coir Rolls were installed to return the average channel width by 25-30%. The rolls were backfilled with locally won soil. The narrowing has had a dramatic impact on the flow of the channel, with a deeper, faster base flow being sustained.
