Yearls Weir Riverbank Reinstatement

Following flooding in west Cumbria, significant bank erosion led to the loss of an access track and compromised the integrity of a weir. Salix were contracted to reinstate the riverbank with a bioengineering solution. The solution consisted of Salix AquaRockBags and large live root wads, to provide erosion protection in a high energy environment.

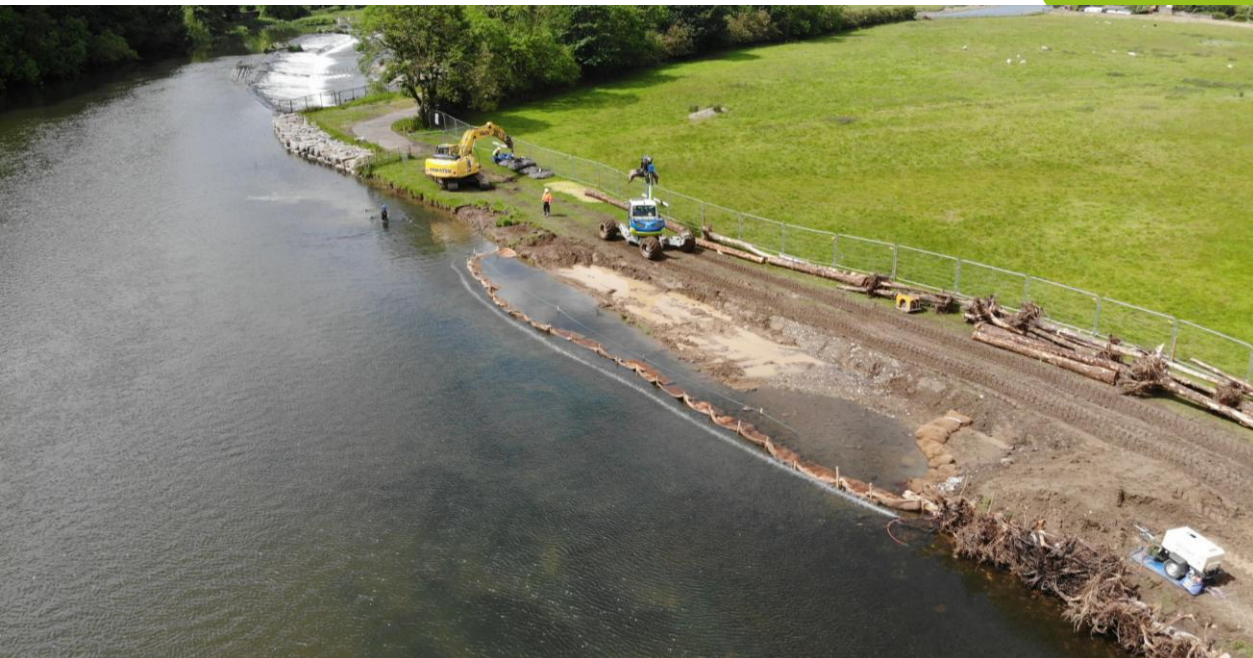
It was necessary to provide an alternative access to the weir, needing some form of protection against future erosion.

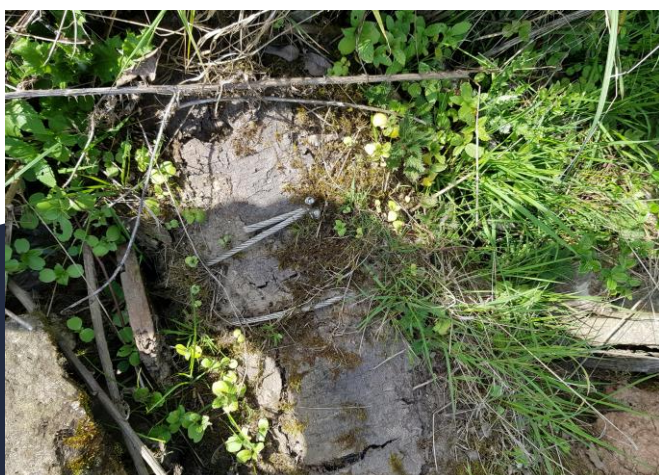
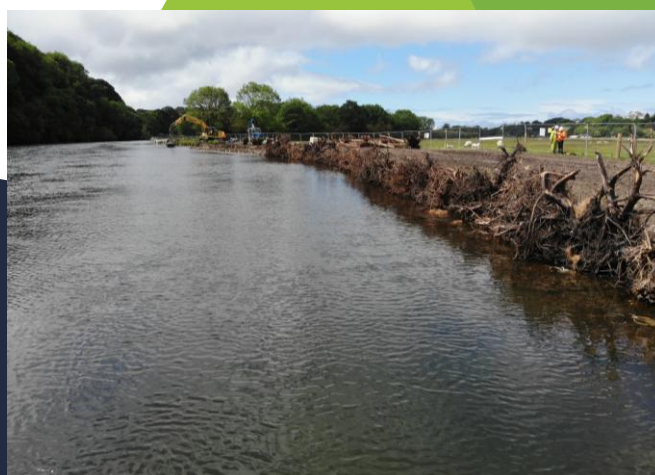
The scour pools provided a particular challenge, as bioengineering techniques would not control the rate of erosion in 2-3 metres of water. Large rip rap stone was also ruled out due to the geomorphological impact downstream and the adverse ecological impact. The solution to controlling the erosion in the scour pools came in the form of AquaRockBags. These were installed to average water level and above this level more traditional bioengineering solution could be used. AquaRockBags support vegetation, invertebrates, and fish. The smaller stone size also negates the issue of the downstream morphological impacts that larger rip rap has on channel processes.

From average low flow water level, a continuous run of linear toe logs, root wads and live willow staking were installed. Additional tree planting on the re-profiled riverbanks and the adjacent floodplain will slow flood flows and reduce erosive force in the future.

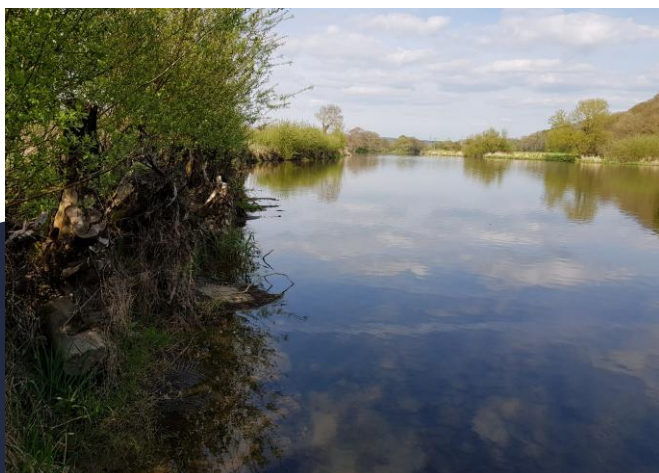
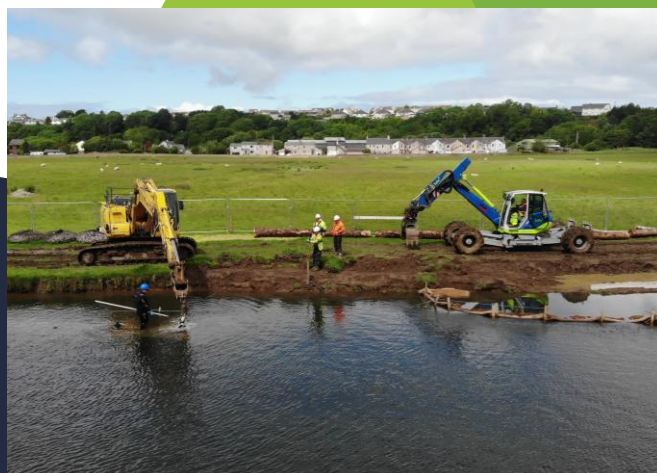
The banks were also protected with a high-performance turf reinforcement system, using a combination of woven HP-TRM and Gripple ground anchors. The matting was extended from the bank to also cover the area where avulsion process had created the new river channel in the floodplain and where future major floods would otherwise try to reform this channel feature.

Since installation, the vegetation has fully established with an abundance of native species. Fry, lamprey and eels thrive in the silted margins, with improved marginal habitat to assist with cover and invertebrate abundance. The large root wad revetment will sustainably protect the bank whilst offering substantial environmental benefits.
