# Caerphilly Castle Habitat Enhancement

## Case Study

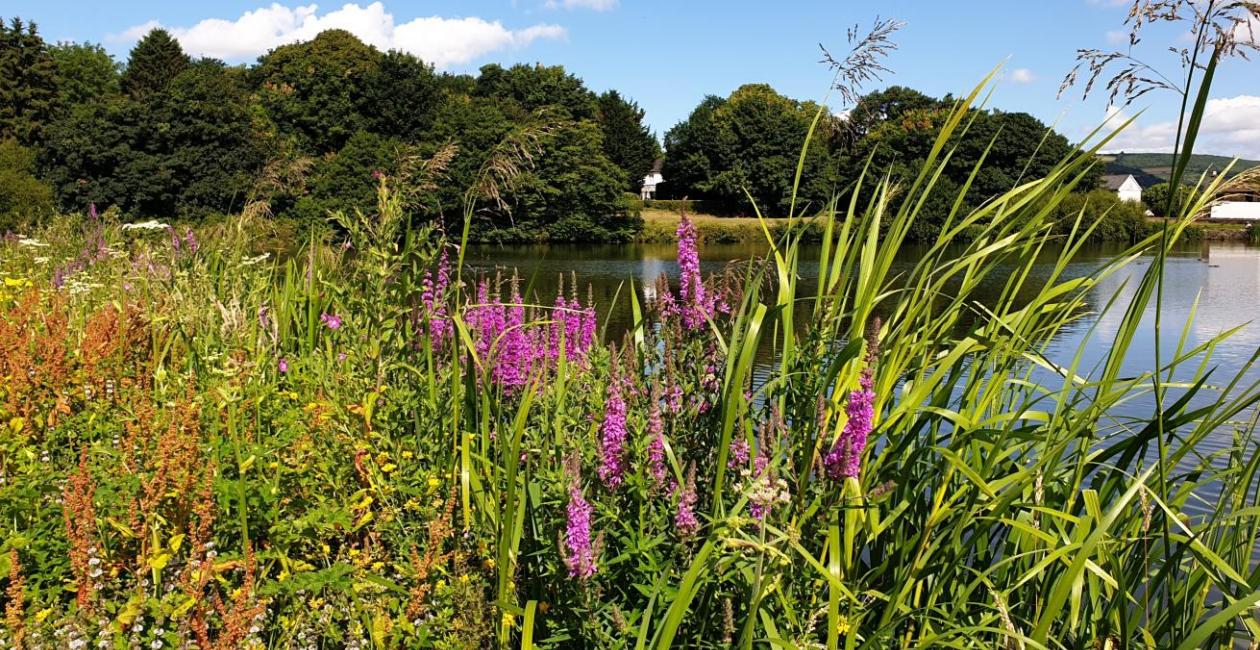
The surrounding moat had large areas devoid of vegetation with bare soils exposed along the water's edge creating a barren site with little biodiversity. A very large Canadian Geese population has also adversely affected the surrounding banks with heavily cropped banks and compacted soils preventing wildflower and marginal plant establishment.

In order to resolve this, Salix supplied and installed over 700m of pre-established coir rolls as an organic revetment, preventing soil erosion along the toe of the moat. The 3m long x 300mm diameter rolls contain a variety of native marginal plants including *Lythrum salicaria*, *Iris pseudacorus*, *Juncus effusus*, *Carex acutiformis* and *Phalaris arundinacea*. These plants provide a good selection of flowering species to attract pollinators and strong root structures to bind the soils and prevent further erosion. The mature planting within the coir rolls is established in wet-beds at our 28 acre in-house wetland nursery for a minimum of 6 months. This solution speeds up the rate of establishment on site and provides instant wetland habitat, which will also improve water quality over time.

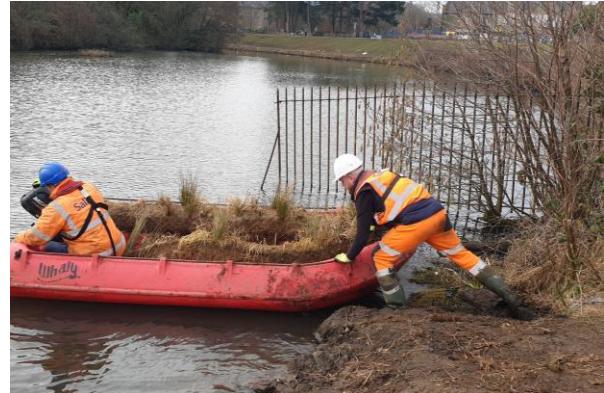
Boat access was required to bring materials adjacent to site works. The coir rolls and Chestnut stakes were easily transported by boat and manually installed.

To protect the newly installed coir roll revetement works, anti wildfowl netting was installed along the perimeter of the works. In urban parks and areas with unnaturally high populations of wildfowl, it's essential to provide protection of Bioengineering solutions. Without this, the Geese would have destroyed the planting and created further erosion issues. After a few seasons when the site has reached full maturity, this netting can be removed.

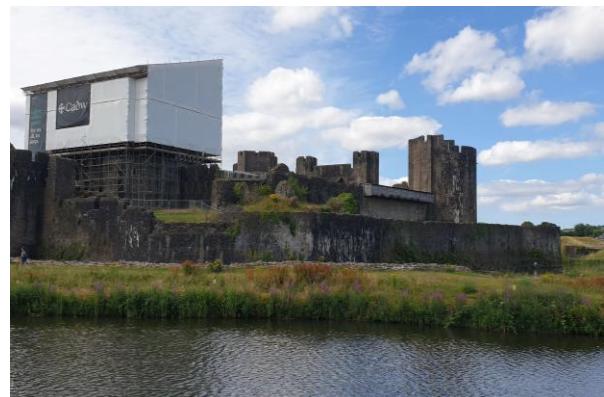
The installation works were carried out in March 2021. Just over a year later in July 2022, the area has been transformed from a barren monoculture of short, cropped grass and bare banks into a wildlife haven capable of supporting a diverse range of species as well as visually enhancing the stunning castle landscape.
