# St Michaels-on-Wyre Flood Protection Repair Works

Erosion Products Used in Flood Protection Repair Works

Salix's products used by VBA Consortium on essential and extensive flood bank repair works

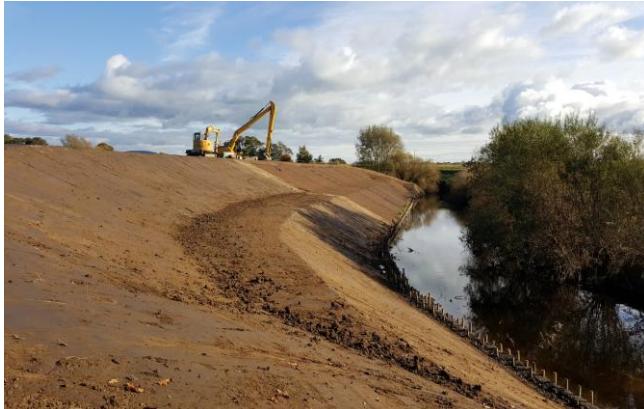
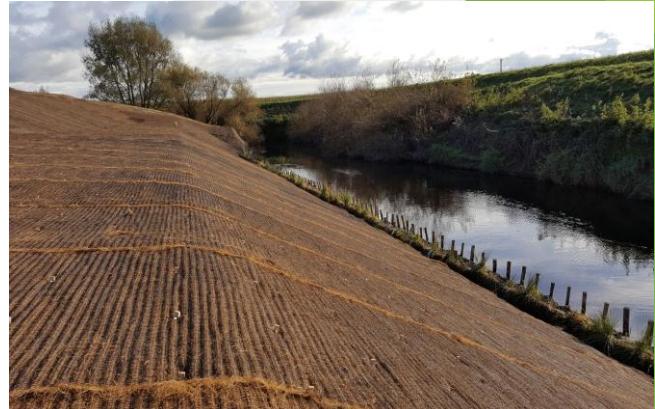
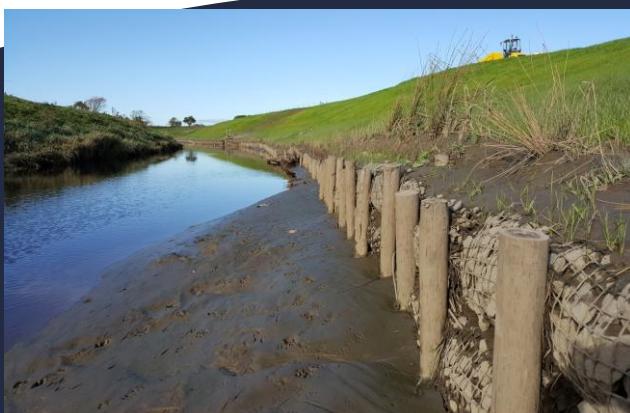
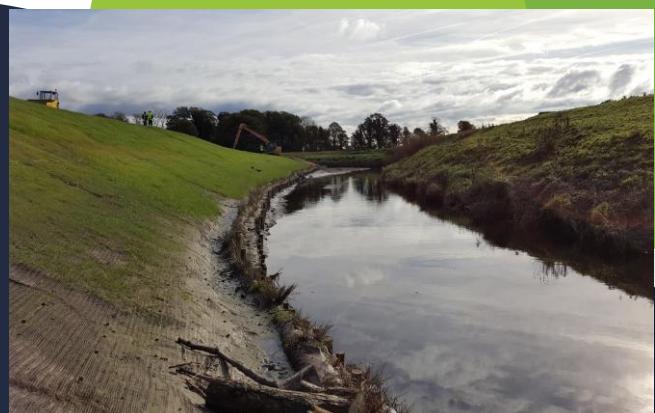
Salix's erosion products were selected to provide the essential combination of erosion protection to ensure the ongoing protection of the flood banks. Rock Rolls and pre-planted Coir Rolls were used at the toe of the bank, these along with the native plants in the Coir Rolls will provide hard wearing erosion protection to the bank. As silt accretes behind the Rock Rolls and Coir Rolls vegetation will establish, the roots will provide further protection to the river bank.

The flood bank was given the additional protection of VMax C350, this was laid over the seeded banks. This product protects the banks from shear stress, so should the area face further severe flooding the matting will ensure soils are protected and the flood bank is maintained. The VMax also benefits the banks by protecting the seeds underneath, warming up the soils and ensuring that the seeds do not get washed away in the rain or from further flooding.
