Design
Build
Products
Nursery

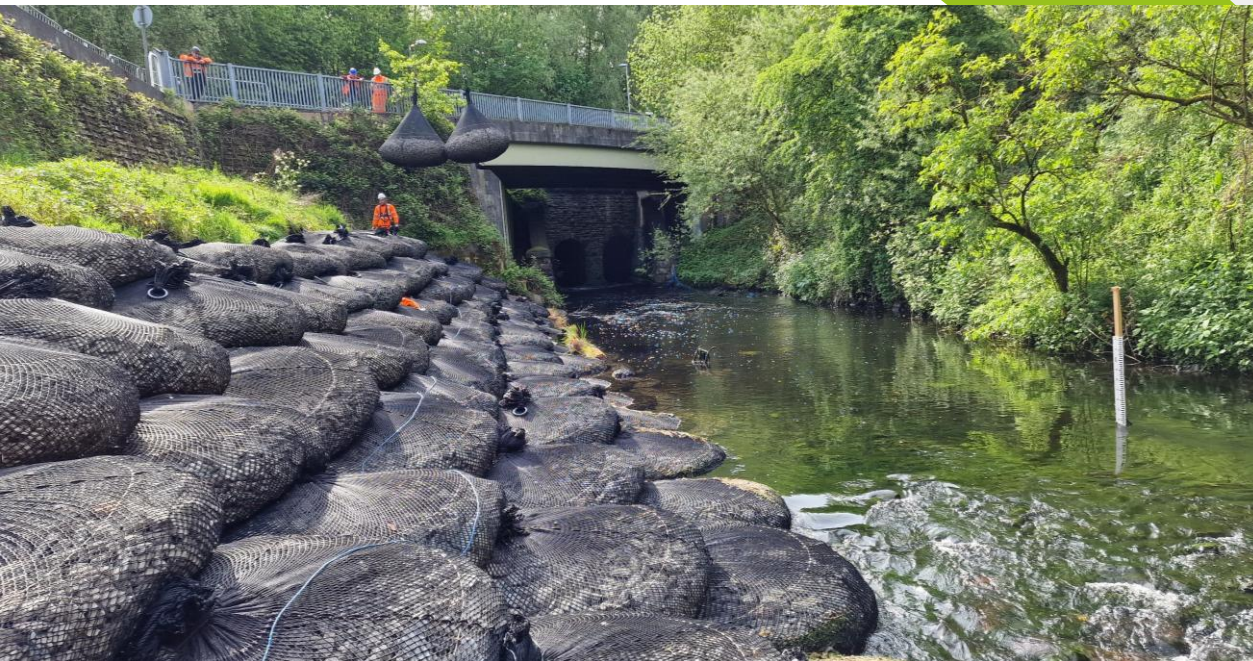
In this case, the business park was experiencing failure from the river undercutting the bank, hence causing tension cracks on the road above, subjecting it to shear failure.

Salix installed AquaRockBags on the foot on the river and left bank, for structural reinforcement and erosion control. AquaRockBags are a semi-natural feature located in an green and blue space which is acting to provide environmental, economic and health benefits through providing erosion control. AquaRockBags are a tough revetment and a form of green infrastructure. They act as a flexible and sustainable alternative to grey infrastructure, often concrete, gabion and rip rap revetments.

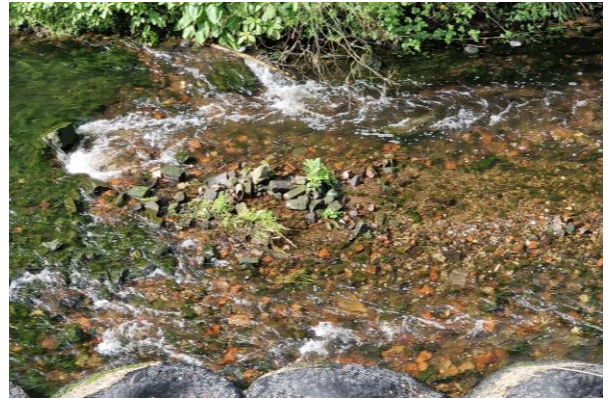
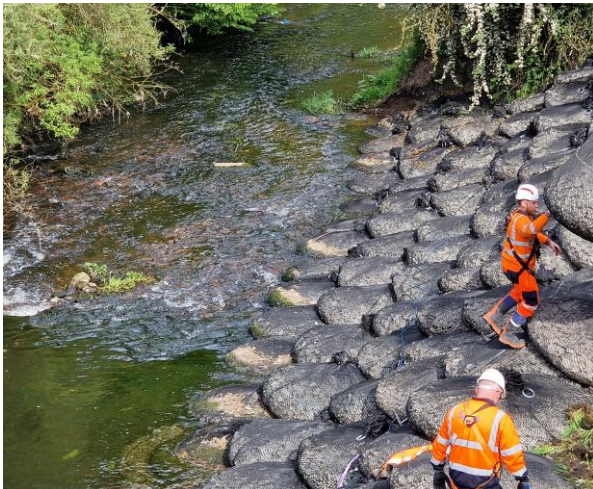
Pre-established coir rolls were used to line the river bank, at the bottom of the first AquaRockBag line. Rock rolls are a robust, permanent and cost-effective revetment, acting as a suitable alternative to rock rip rap and gabions. The selection of species is an important consideration; parameters such as soil type, water quality, lighting conditions and inundation depth was all taken into account for Salix to advice and provide the best product for this site.

The AquaRockBags were built up to reach the concrete wall, forming a gentle gradient. This simple slope gradient was derived using knowledge of bank stability equations and critical caving erosion width (CCEW) formulas; CCEW decreases when the slope angle of the bank increases (Wang et al., 2016). Due to access being limited, a crane, positioned at top of the road and was used to gently lower and install each individual AquaRockBag.

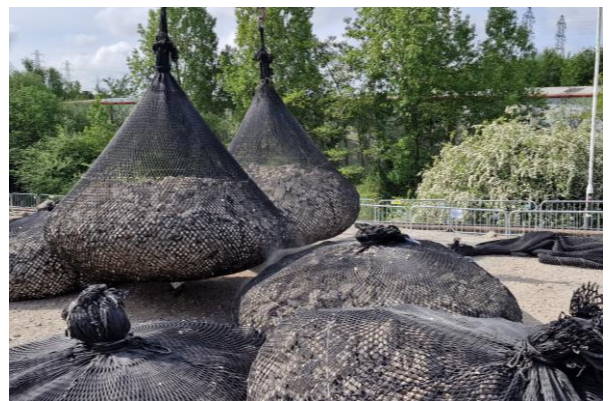
Sheet piling was used at the back of the bank behind the AquaRockBags to provide structural support and ensure absence of any further erosion undercutting the bank. AquaRockBags not only reduced the amount of sheet piling that was necessary to use, but also enhanced the aesthetics and biodiversity of the area. After installation the AquaRockBags were soiled and seeded with a standard mix of wetland species.
