### Cwmbran Boating Lake Improvements

<b>PROJECT NAME :</b>	Cwmbran Boating Lake Improvements
<b>CLIENT :</b>	Torfaen Council and Blakedown Landscapes
<b>LOCATION :</b>	Cwmbran, South Wales
<b>PROJECT CATEGORY :</b>	Lakes, ponds and shorelines

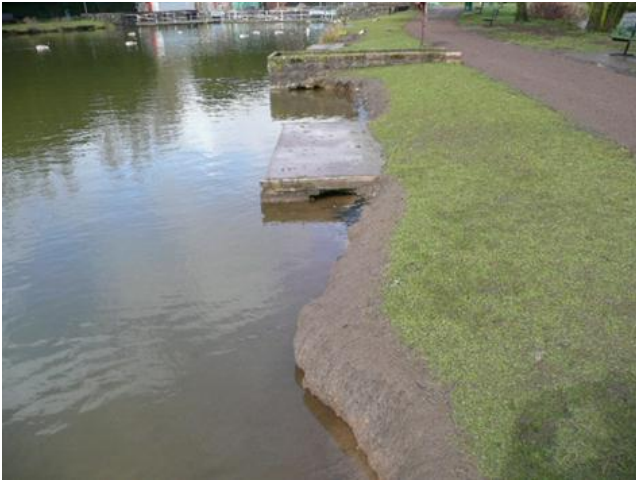
The boating lake was a popular local attraction and fishing lake. The lake edges were in bad repair with little or no marginal vegetation. Floating islands were also required to add further habitat for fish and wildfowl.

Typical state of lake edge prior to works

In order to create a wide marginal edge for the lake, Salix installed pre-established coir rolls, manufactured and grown at our in house nursery in Norfolk. Brushwood faggots were used in some areas to lift the coir rolls to the correct level. Behind the coir rolls a mixture of native wetland plug planting using bare root, 110cc and 230cc root trainers grown at our nursery in Gower were planted. Pre-established coir pallets were also used on the ledges to create a more instant effect than the plug plants.

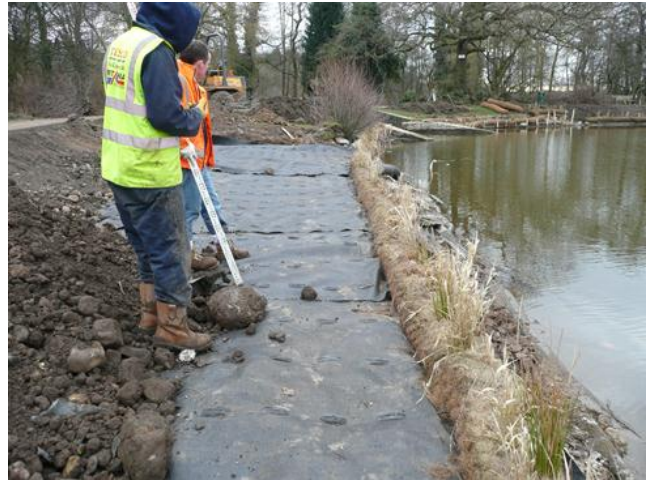
Coir rolls placed onto woven geotextile and backfilled

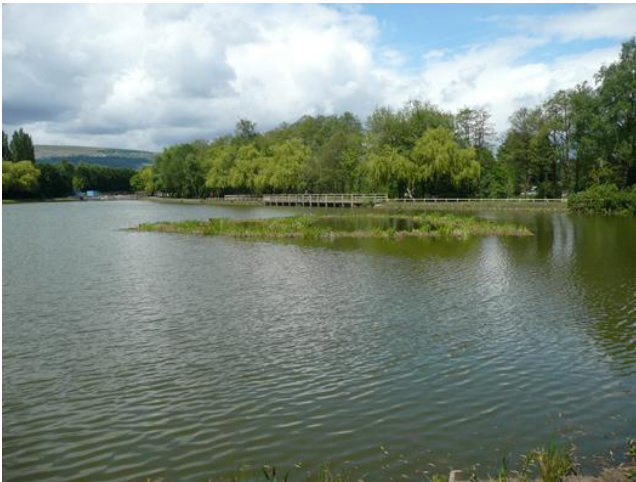
Floating island newly installed

Salix also installed 23 number 3m x 3m floating island units attached together to form an irregular shaped island with an open water middle. The island was pre-vegetated using our pre-established coir pallets. The calm central water area created by the floating islands encourages further bio diversity such as Dragonfly to use the site. The islands also provide shelter for fish fry and larger fish.

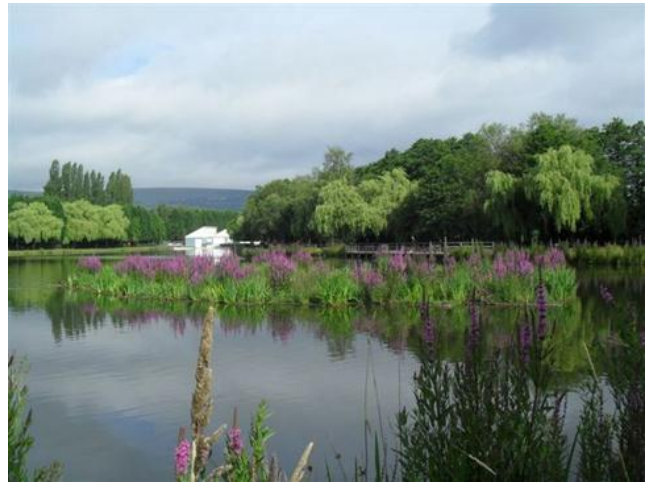
Floating island one year later

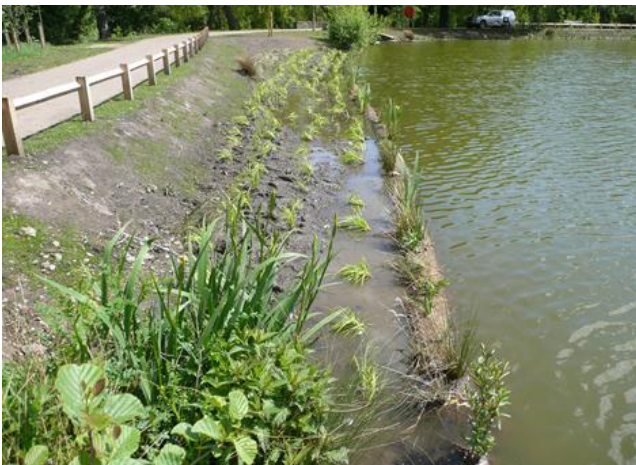
Newly installed Coir rolls and wetland planting

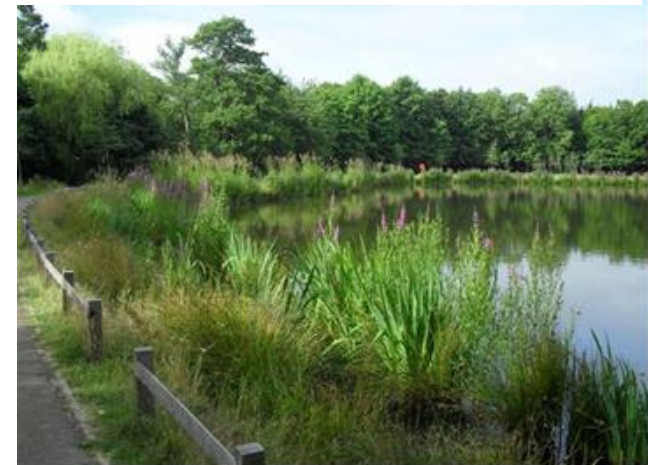
One year later excellent marginal habitat
