Ramsden Bellhouse and Kent Hill

PROJECT NAME :	Ramsden Bellhouse and Kent Hill
CLIENT :	Kier Rail
LOCATION :	Essex
PROJECT CATEGORY :	Rail, Slope soil erosion control

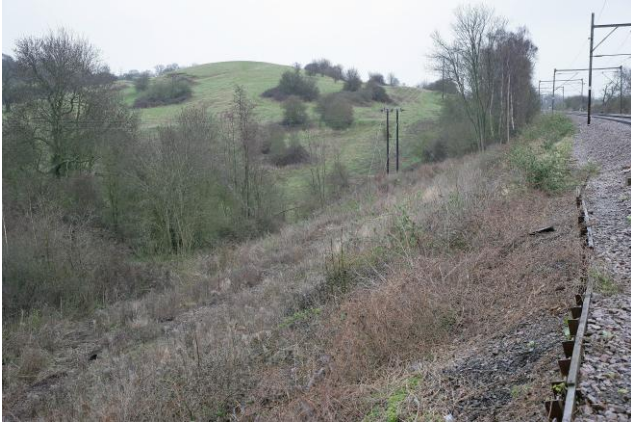
A series of potentially dangerous deep seated failures on a railway embankment required treatment to prevent further slips. The geotechnical issues of ground stability were resolved using soil nailing. The surface erosion was solved by using North American Green (NAG) C350.

Failed embankment

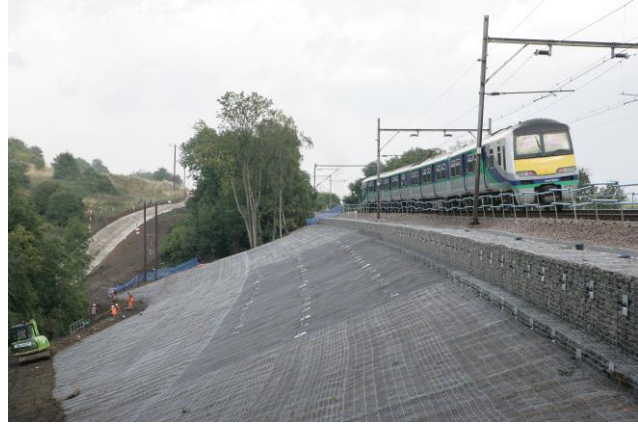
Vmax C350 under rock netting

NAG C350 is composite Turf Reinforcement Mat (TRM) and was installed over prepared seeded topsoil. The whole surface was then covered with rock netting. The NAG C350 is a permanent solution that will offer long term erosion control and vegetative reinforcement.

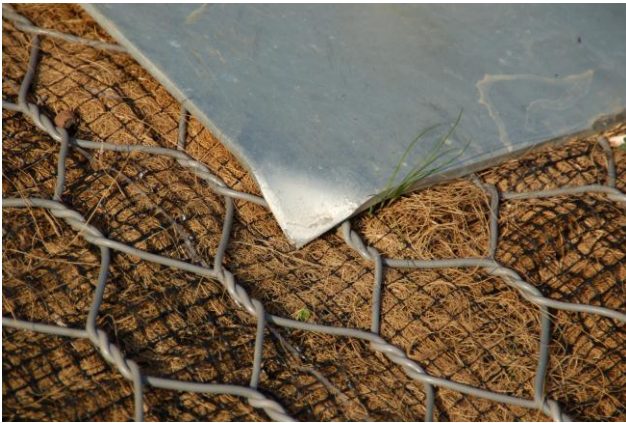
Close up of Vmax C350

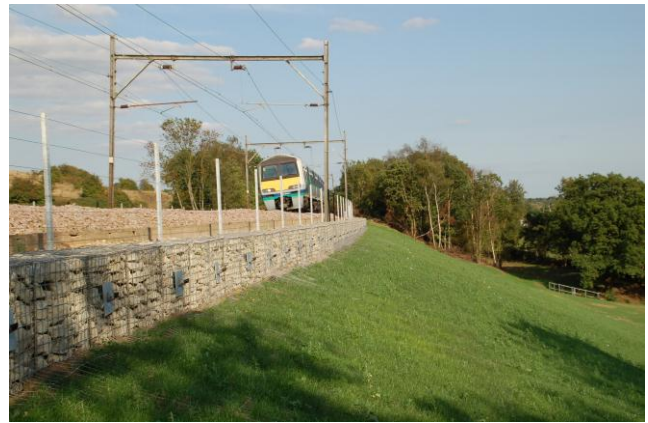
Fully vegetated
