### River Thaw Enhancement, Cowbridge, South Wales

<b>PROJECT NAME :</b>	River Thaw enhancement
<b>CLIENT :</b>	Environment Agency Wales
<b>LOCATION :</b>	Cowbridge, Vale of Glamorgan
<b>PROJECT CATEGORY :</b>	Habitat Creation, Lowland River

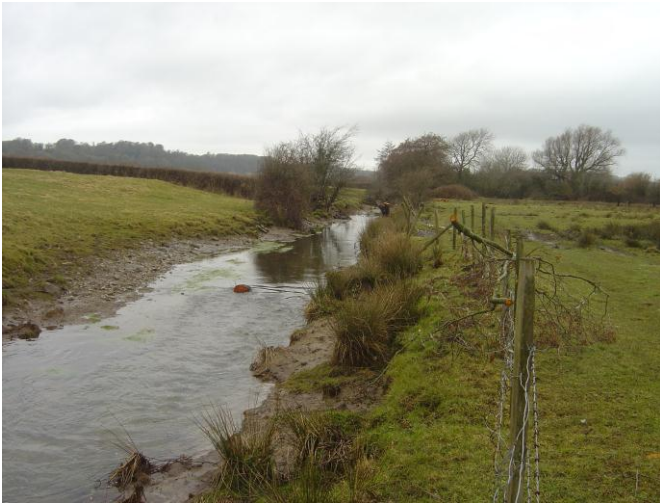
Over wide channel lacks biodiversity

Salix conducted a basic walk over survey and concluded that the degraded reach was 25-30% wider than unaffected reaches up and down stream. The over wide channel had lost much of its physical habitat value due to the poaching.

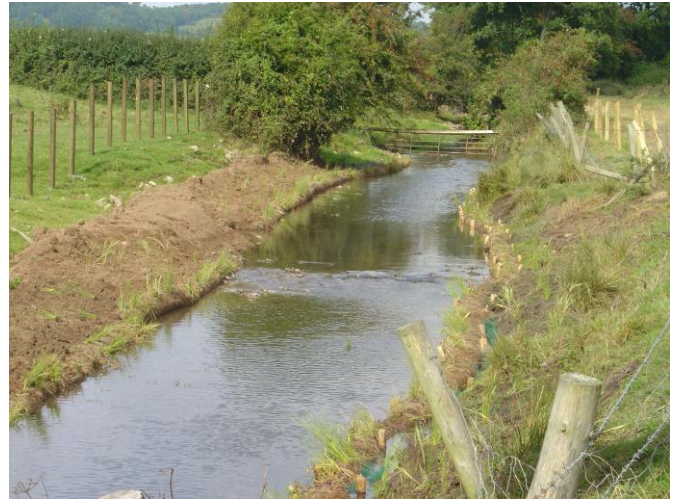
Pre-established coir rolls set into channel

Salix undertook channel restoration works as part of a larger flood defence scheme and were designed to mitigate habitat loss due to the infrastructure works. Coir rolls were installed to return the average channel width by 25-30%. The rolls were backfilled with locally won soil. The narrowing has had a dramatic impact on the flow of the channel, with a deeper faster base flow being sustained. This has allowed submerged vegetation to re-establish and provide excellent physical habitat structure within the channel. The pre-established coir rolls have rapidly controlled

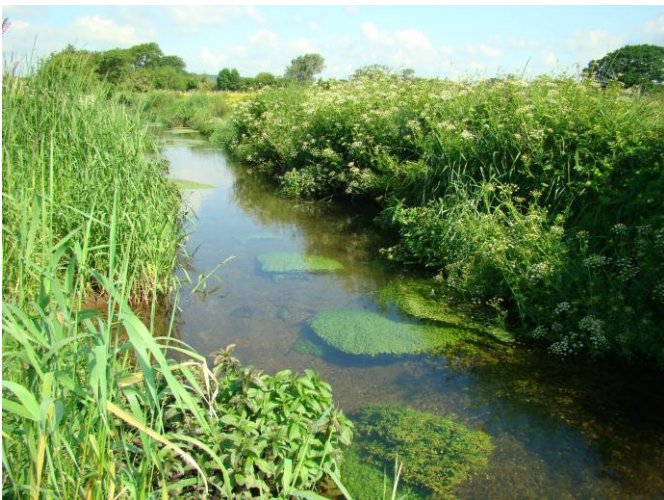
One year later. Diverse marginal vegetation and physical structure to bank.

bank erosion and have provided a physical habitat with the diverse vegetation establishment of marginal and bankside species.

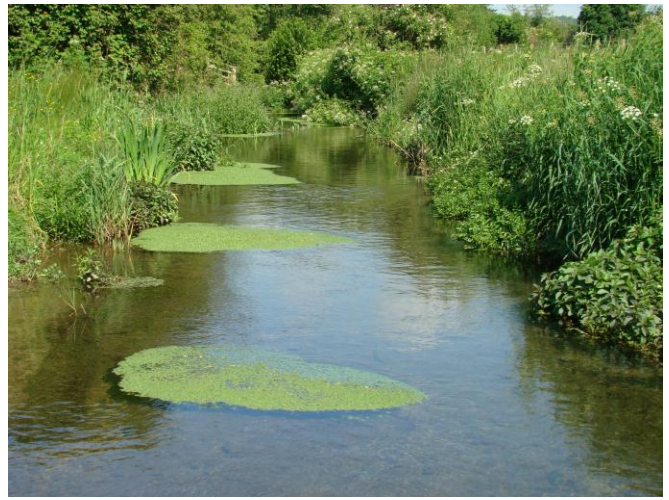
Channel narrowing and in channel and bankside vegetation creates concentrated base flow with locally complex flow diversity
